Nahant Thicket Wildlife Sanctuary Ecological Restoration and Maintenance Plan

Mass Audubon's Ecological Extension Service

September 2017

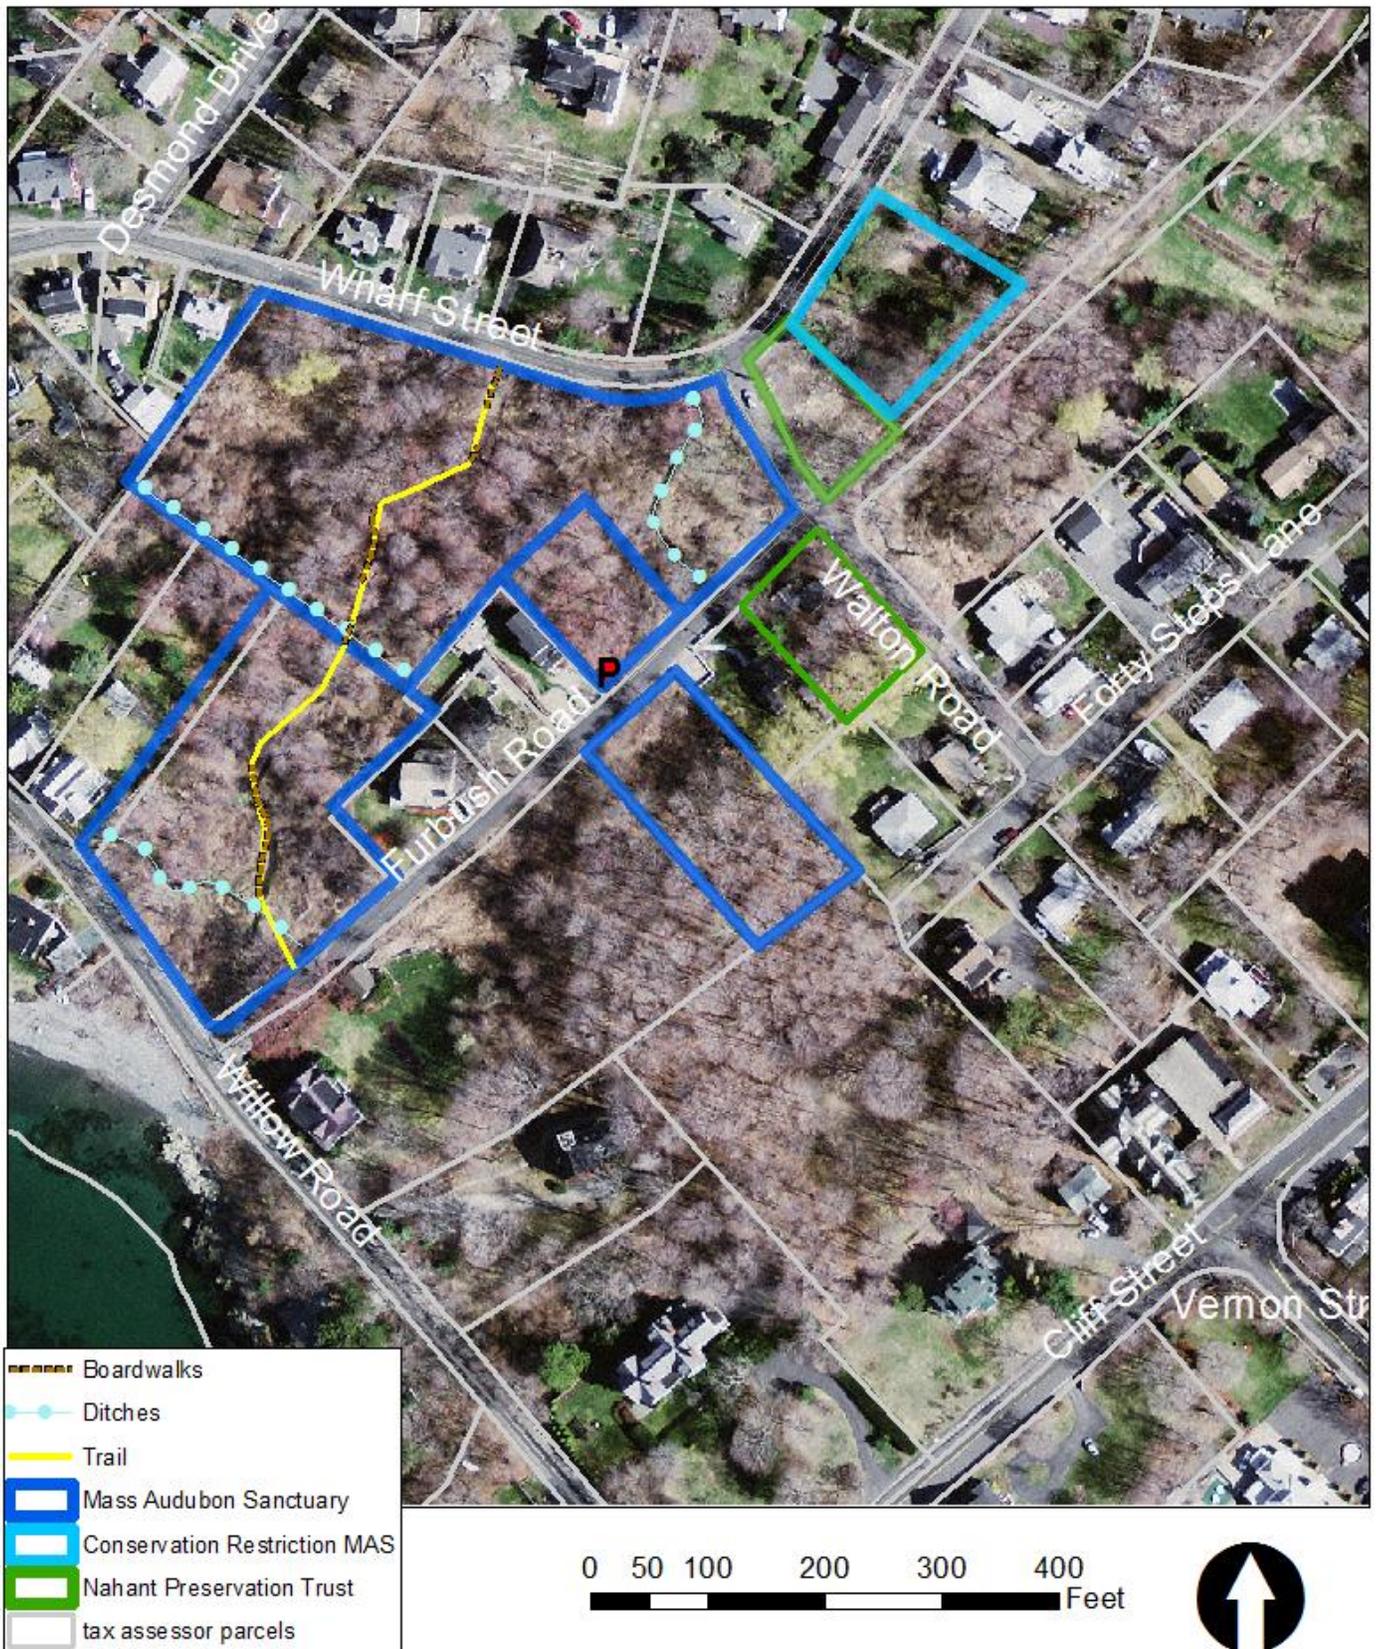
Figure 1: Current Conditions of Nahant Thicket

The Thicket is an assemblage of Mass Audubon fee owned land as well as one parcel protected by Mass Audubon with a Conservation Restriction (CR). There are currently roughly 1,000 feet of trail, 250 feet of which run along wooden structures such as boardwalks, bridges, and steps. Three ditches run through the property, with two lateral ditches draining into a central ditch which runs to pipes underneath Furbush Road, eventually flowing into the ocean on the south side of Willow Road. There is a small parking area along Furbush Road that accomodates two cars (see Figure 1).

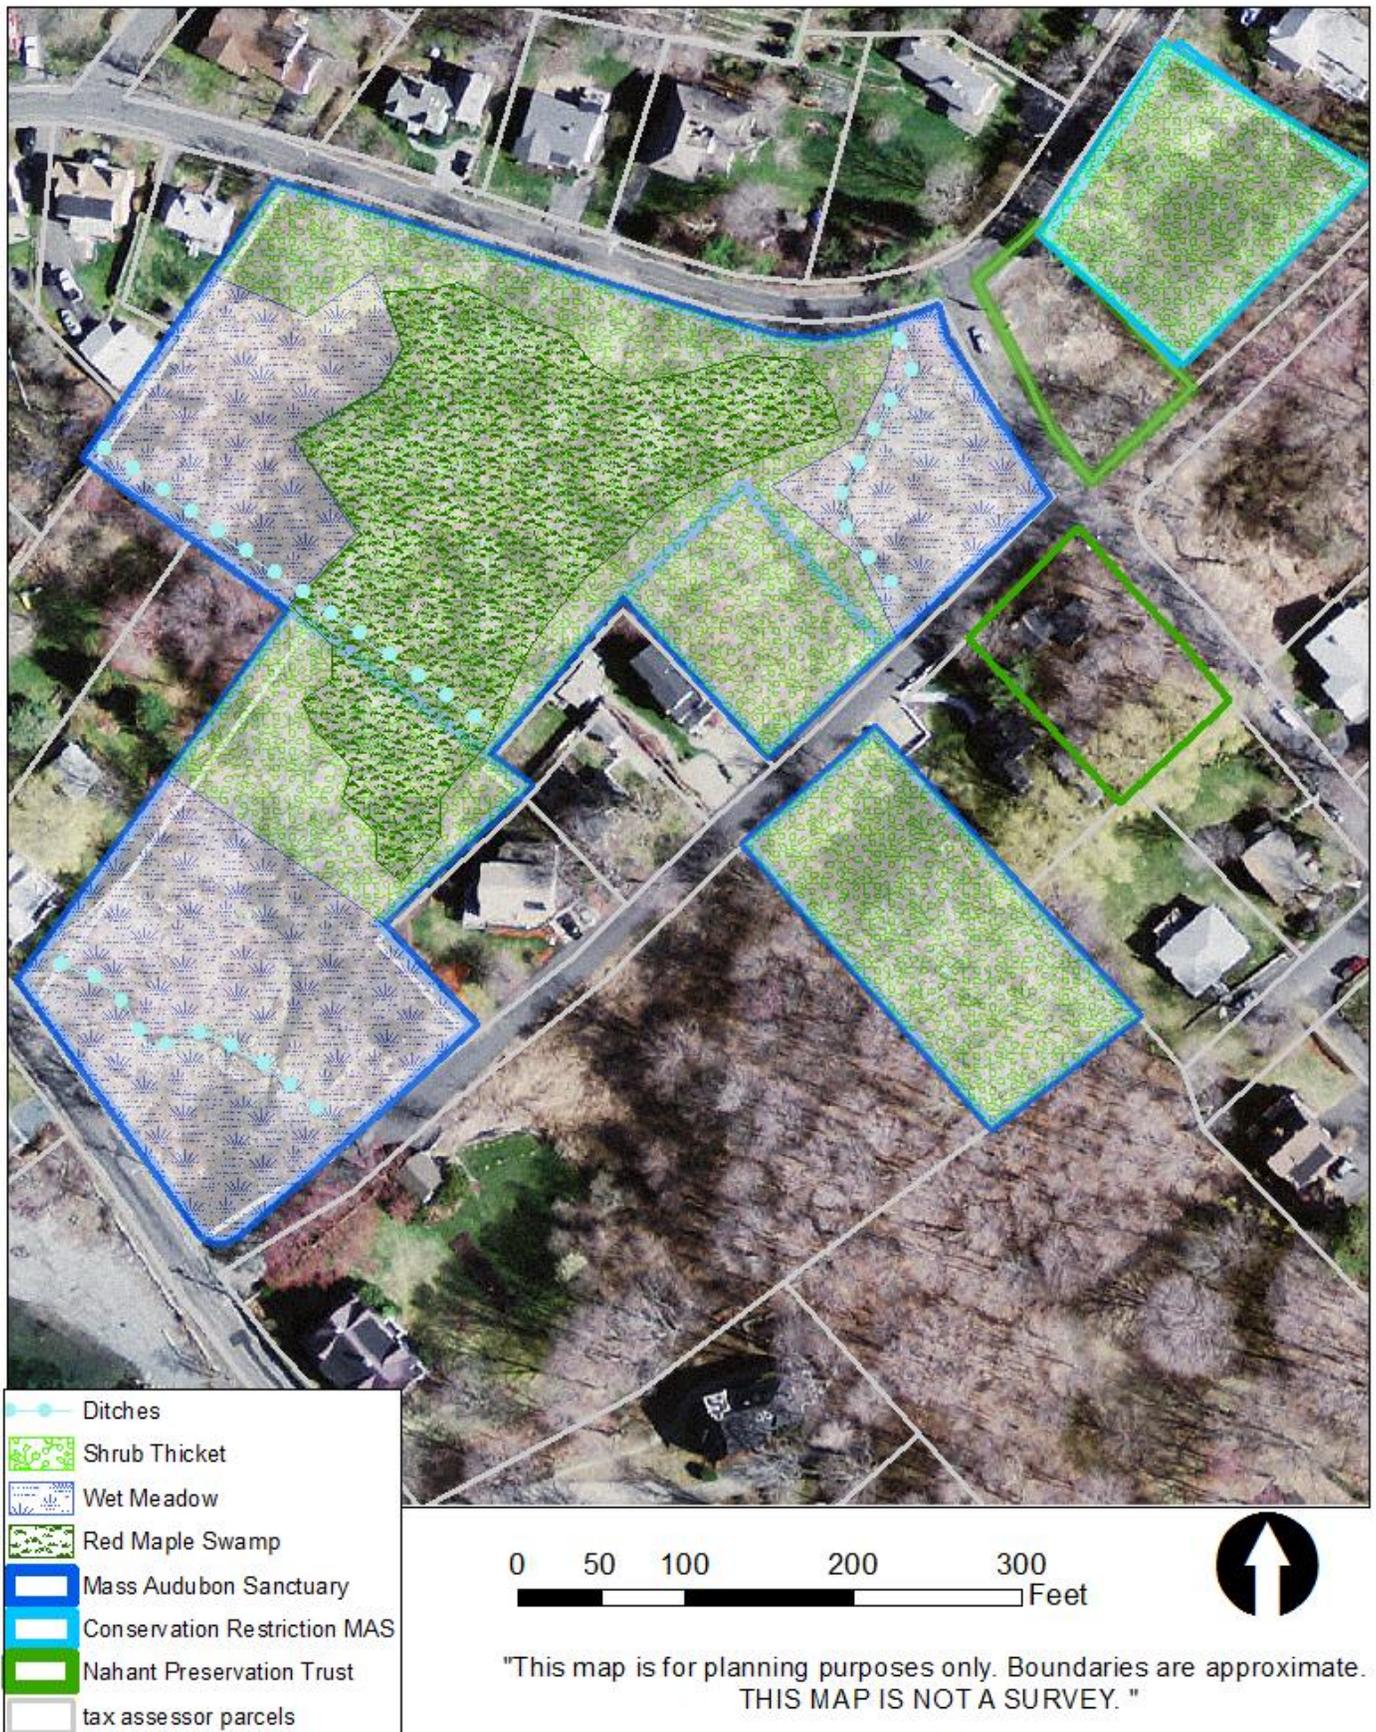
Figure 2: Ecological Cover Types at Nahant Thicket

The sanctuary can be divided into three major cover types: Wet Meadow, Red Maple Swamp, and Shrub Thicket. The Wet Meadow areas are located in the southwest, northwest, and northeast corners of the property; the Red Maple Swamp dominates the central portion of the property and the parcel southeast of Furbush Road; while Shrub Thicket is characteristic of the meadow edges and roadside vegetation,

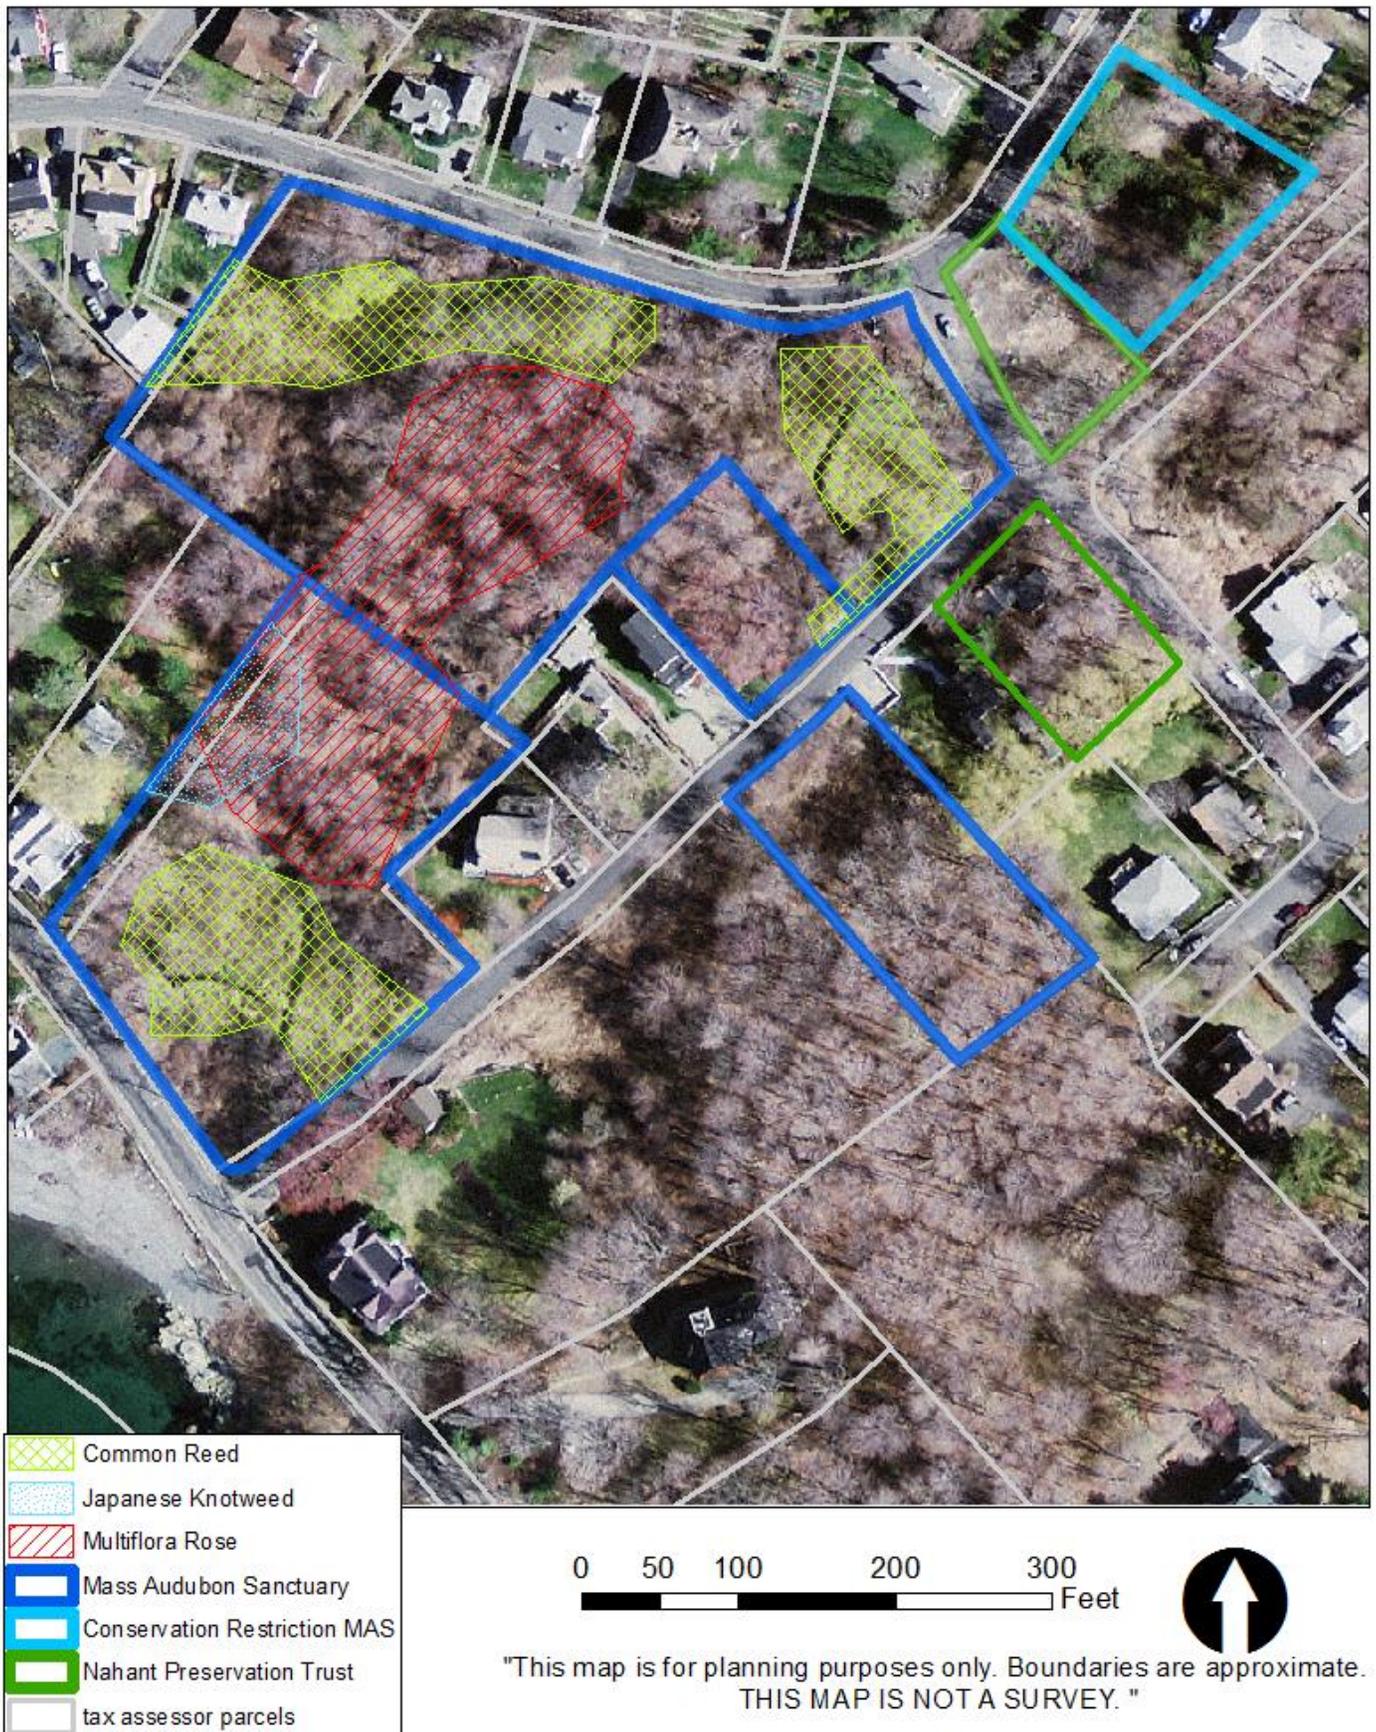
Figure 3: Distribution of the most common invasive plants at Nahant Thicket.

Invasive plant species are common and widespread on the sanctuary (Figure 3). The most common invasive species are common reed (*Phragmites australis ssp. australis*), multiflora rose (*Rosa multiflora*), oriental bittersweet (*Celastrus orbiculatus*), and Japanese knotweed (*Polygonum cuspidatum*). Other invasive plant species present are Norway maple (*Acer platanoides*), sycamore maple (*Acer pseudoplatanus*), garlic mustard (*Alliaria petiolata*), dame's rocket (*Hesperis matronalis*), Morrow's honeysuckle (*Lonicera morrowii*), winged euonymus (*Euonymus alatus*), purple loosestrife (*Lythrum salicaria*), border privet (*Ligustrum obtusifolium*), and common buckthorn (*Rhamnus cathartica*).

Species	Location and Abundance
Norway maple	A few individuals on higher ground along the sanctuary boundaries.
Sycamore maple	A few individuals on higher ground along the sanctuary boundaries.
Garlic mustard	A few individuals along the roads that bound the sanctuary.
Dame's rocket	A few scattered individuals along the roads that bound the sanctuary.
Goutweed	Small populations in southwest corner of sanctuary.
Morrow's honeysuckle	Scattered individuals in drier areas along the sanctuary boundaries and interior.
Oriental bittersweet	Common in drier areas, especially along the streets that bound the sanctuary.
Winged euonymus	Scattered individuals in drier areas, especially along the streets that bound the sanctuary.
Border privet	Scattered individuals in drier areas, especially at the south end of the sanctuary.
Purple loosestrife	Scattered individuals along the roads that bound the sanctuary.
Japanese knotweed	Several small stands on northwest side near the property boundary (Figure 3).

Common buckthorn	Scattered individuals along the streets that bound the sanctuary.
Multiflora rose	Dense thickets in many areas, especially along the trail in the interior of the sanctuary (Figure 3).
Common reed	Several stands occupy approximately one acre (25%) of the sanctuary (see Figure 3).

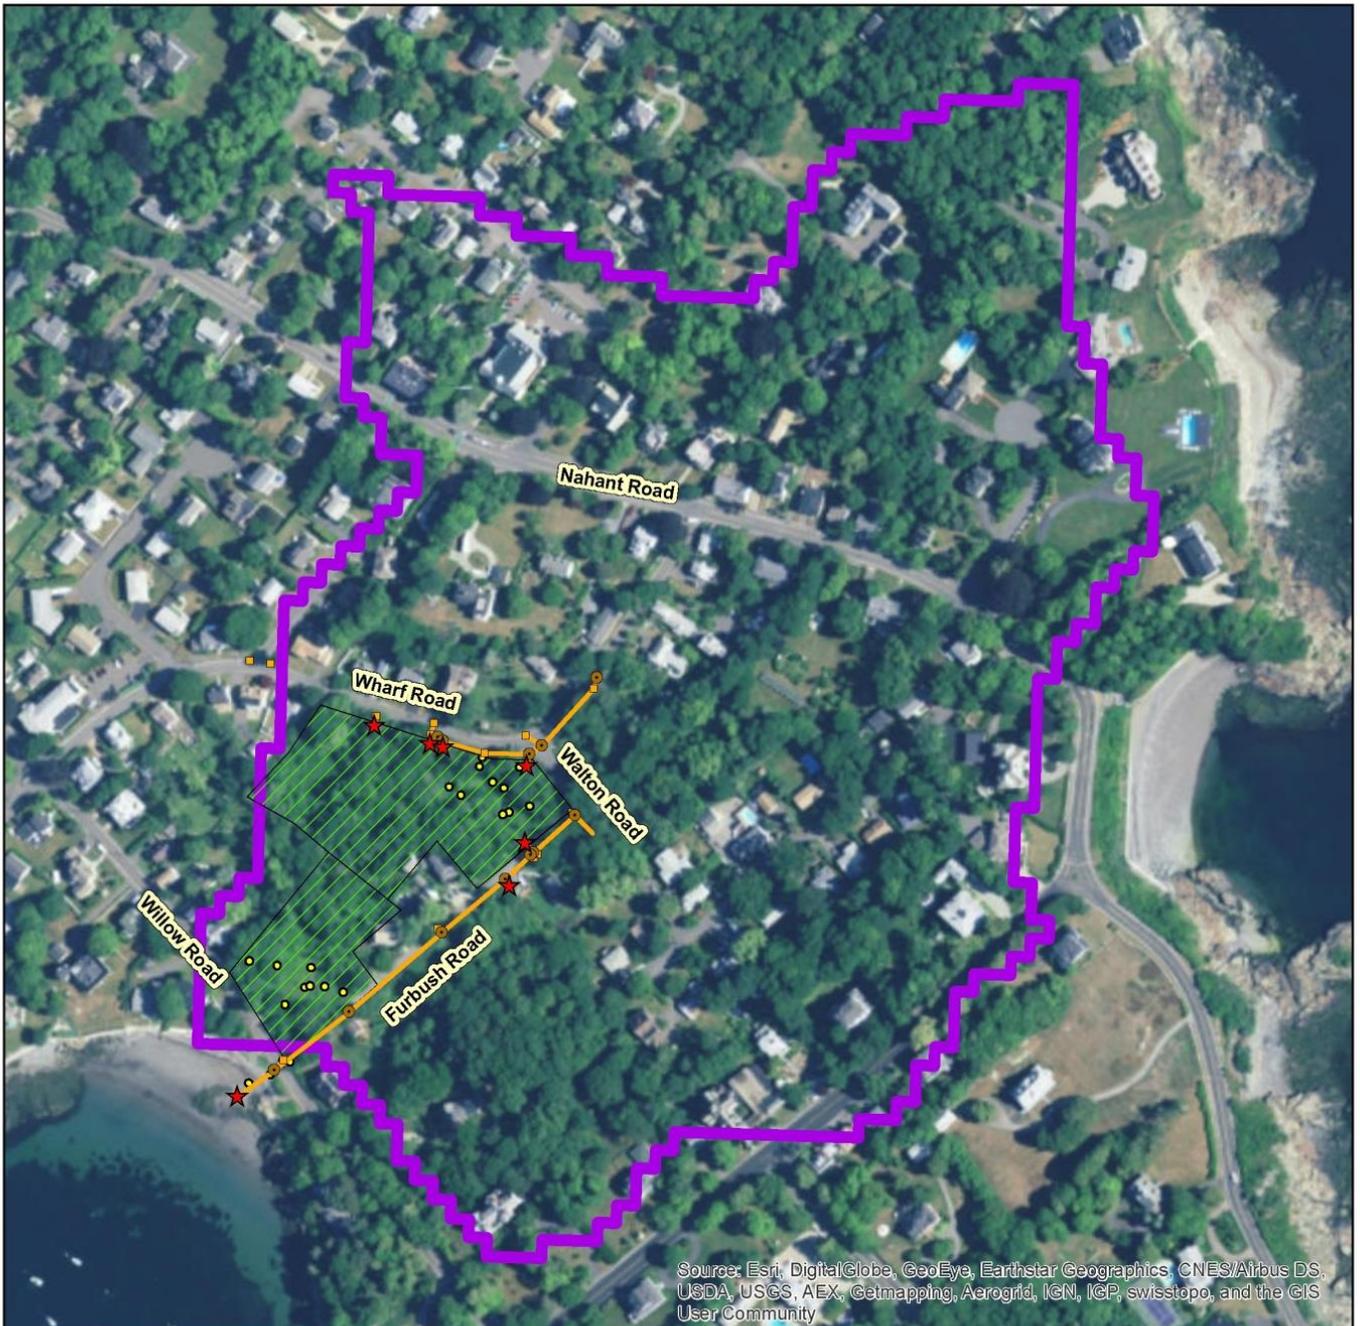
Figure 4: Extent of surrounding drainage into Nahant Thicket. Taken from Inter-Fluve hydrology report.

The property is located in a shallow valley surrounded by higher land to the north, west, and east, spilling out to the ocean to the south. As a result, the sanctuary receives storm water runoff and groundwater drainage from the surrounding residential neighborhood (Figure 4). The property is currently drained by a system of ditches and culverts ultimately draining to a stormwater pipe underneath Furbush Road which drains to the beach south of Willow Road (Figure 5).

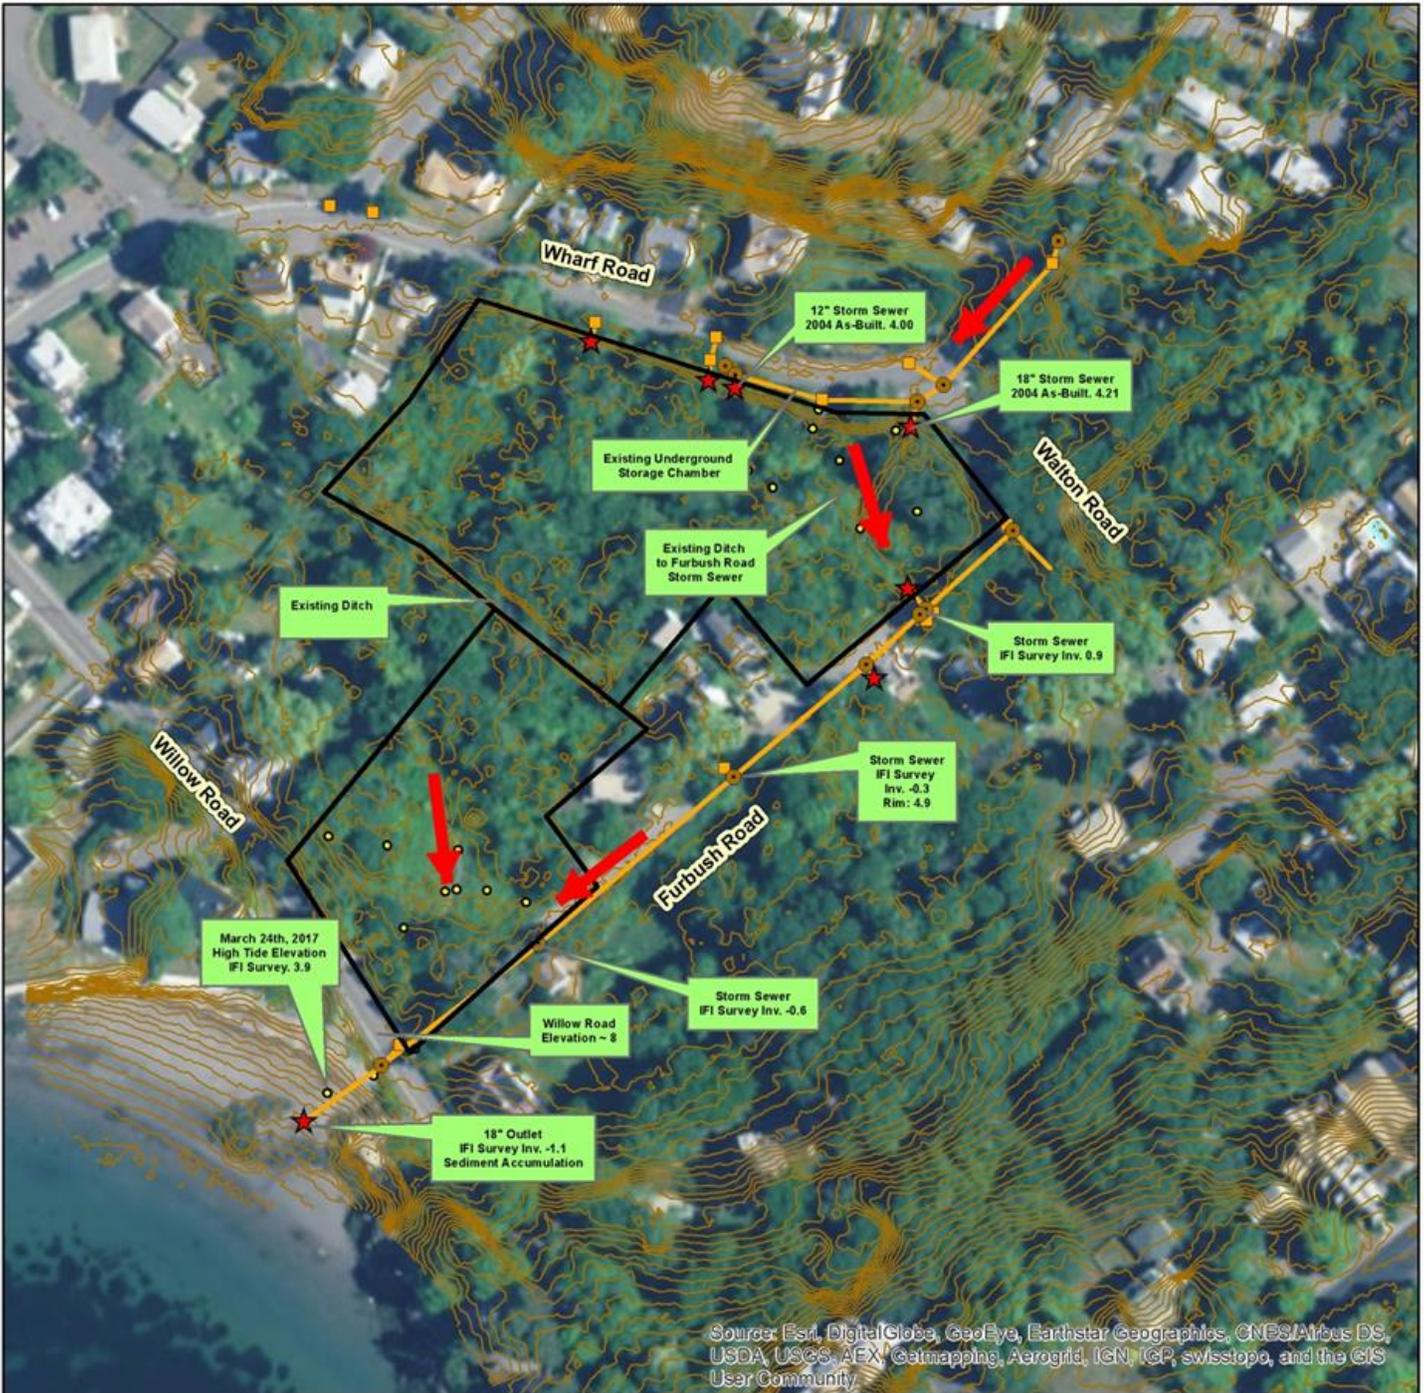
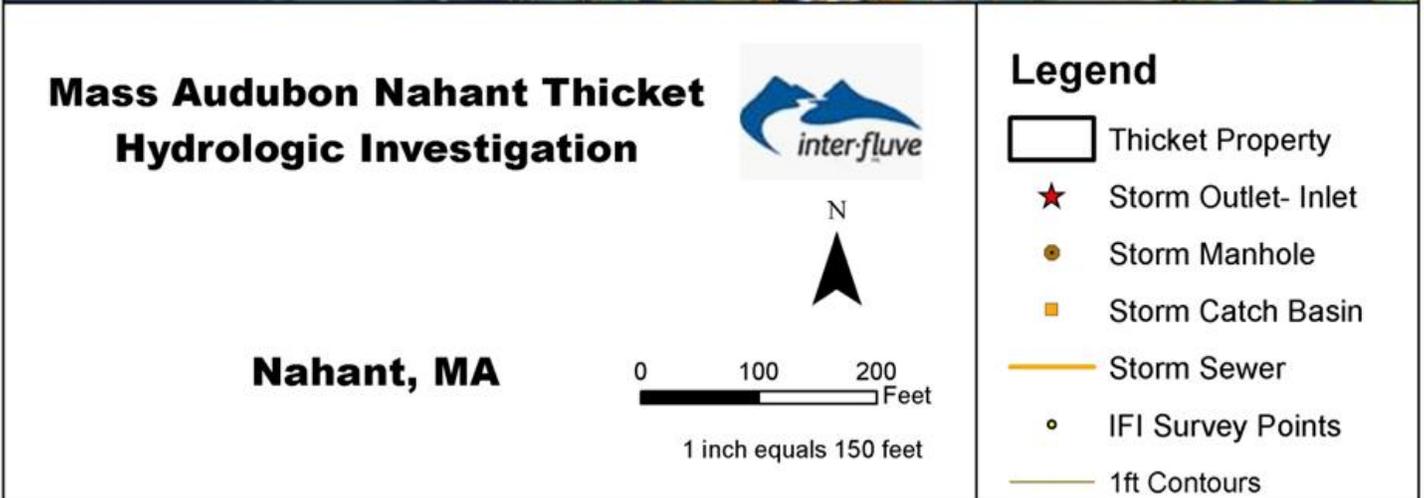
Figure 5: System of ditches and culverts for drainage at Nahant Thicket. Taken from Inter-Fluve Hydrology report.

Within the site, water is conveyed in three primary channels to Furbush Road:

Channel 1 -- A small ditch, approximately 8 feet wide and 1-2 feet deep located at the northeastern corner of the thicket. This channel receives stormwater outfall from Wharf Street and Walton Road, and drains southwest for approximately 80 feet and then southeast for another 80 feet before entering a pipe under Furbush Road. This pipe presumably connects with the main stormwater line under Furbush Road.

Channel 2 -- A widened ditch running west to east through the center of the Thicket. This channel drains water from the western part of the property, flowing northwest to southeast before entering an underground pipe on the west side of the abutting property at 18 Furbush Road. We presume that the underground pipe connects the stormwater pipe under Furbush Road. Although this channel has been maintained in the past for mosquito control, it is fairly vegetated now and retains puddled water. A grate at the downstream end of the channel becomes tends to become clogged with debris which also backs up water into the ditch.

Channel 3 -- At the southwestern end of the site, water drains through narrow swales less than one foot in depth before entering a pipe that we believe connects with the main stormwater system under Furbush Road. Field observations indicated that the pipe leading to Furbush Road is broken and may need repairs.

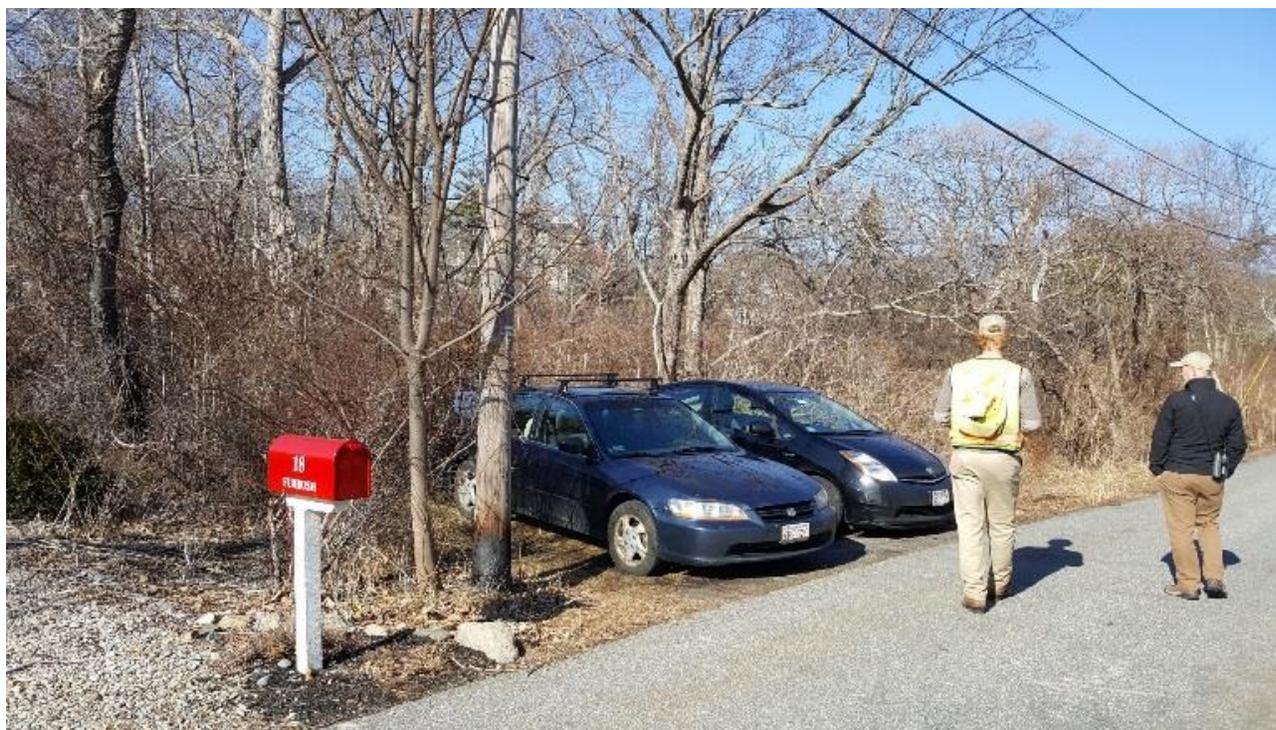
Figure 6: Parking on the North side of Furbush Road

Parking currently consists of two narrow, unsurfaced spaces directly abutting Furbush Road, adjacent to #18 Furbush Road (Figure 6). These spaces are relatively shallow and will comfortably accommodate only smaller vehicles. A small Mass Audubon parking sign indicates the parking spots. There is no trailhead at the parking area; visitors must walk either south along Furbush Road to the southern trail outlet or north on Furbush to Walton and Wharf to the northerly trail.

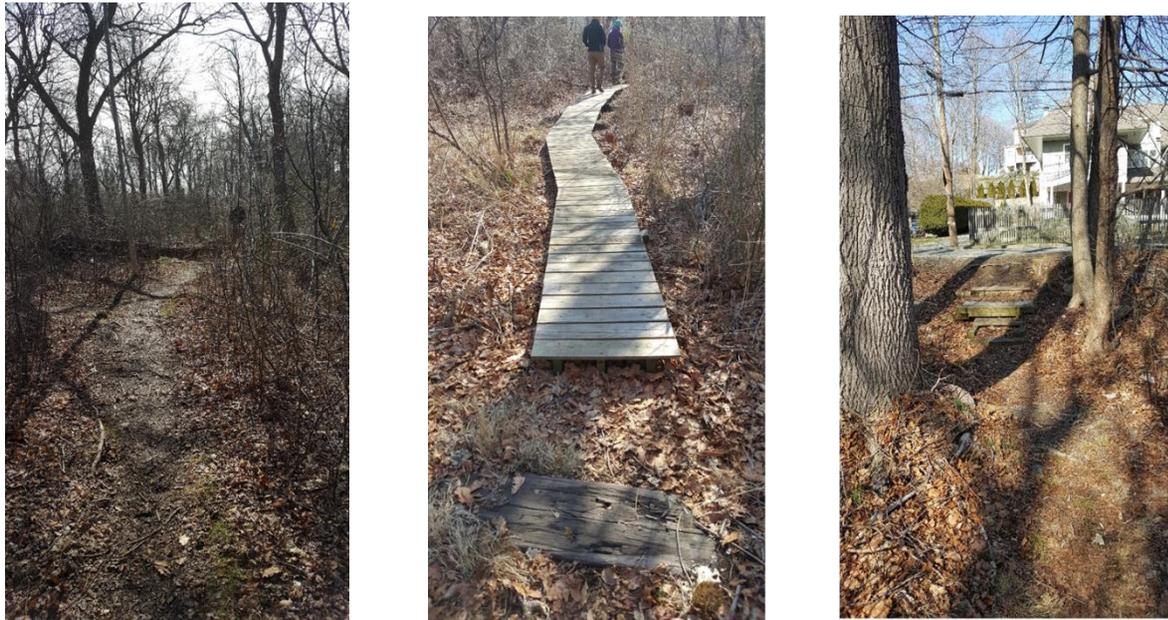
Figure 7: Existing trail conditions for the main trail.

A relatively narrow trail consisting of dirt surface and sections of boardwalk stretches approximately 1,000 feet from the southeast corner of the property on Furbush Road to the northern side of the property on Wharf Street (Figure 7). The trail includes roughly 200 feet of wooden boardwalks and a wooden bridge across the largest drainage ditch on the property (Figure 8). The trail includes three wooden steps up to Wharf Street and the boardwalks and the bridge require stepping up from and down to the dirt trail segments. The bridge is not of the most stable design and gaps at either end require a mindful step when going from the bank to the bridge.

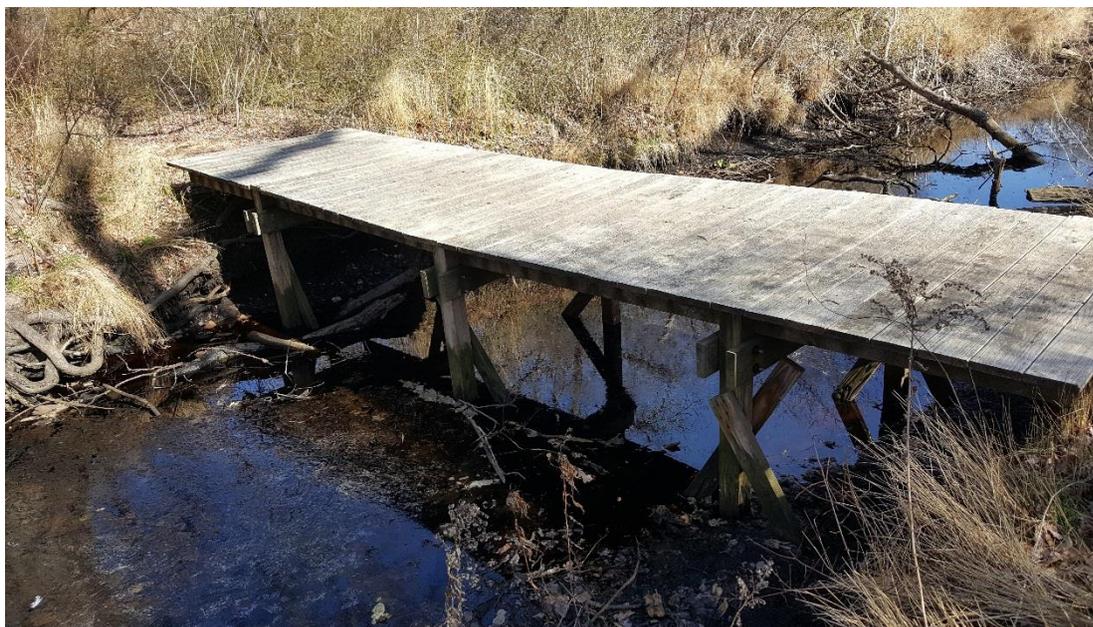
Figure 8: Bridge over central ditch.

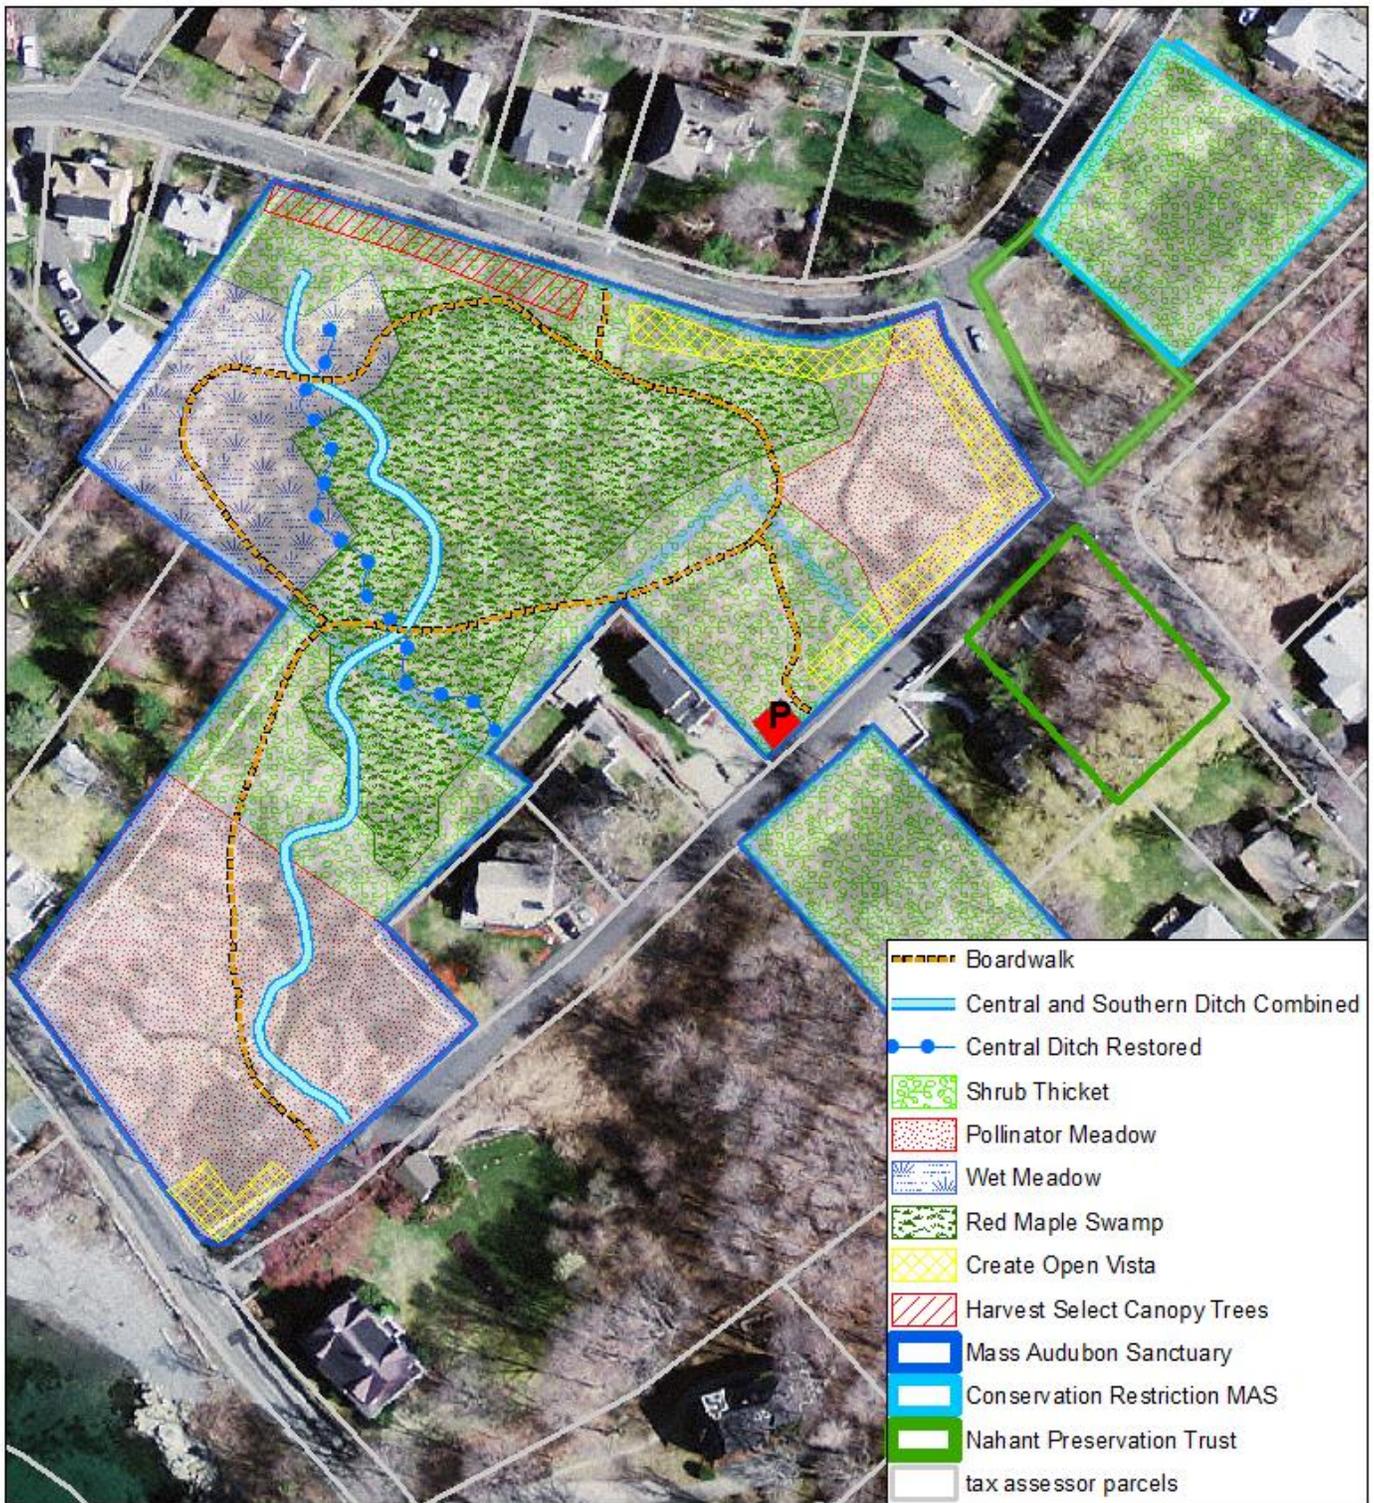
Figure 9: Map of Proposed Restoration areas.

Vegetation management will focus on enhancing wildlife habitat and improving the visual appeal of the site, particularly from the external perspective (Figure 9). We will reduce the presence of invasive plants, replace invasives by planting native shrubs, supplement existing Wet Meadow vegetation with additional wildflowers, and manage woody and herbaceous vegetation along the road frontage to present a more aesthetically pleasing aspect to the sanctuary exterior.

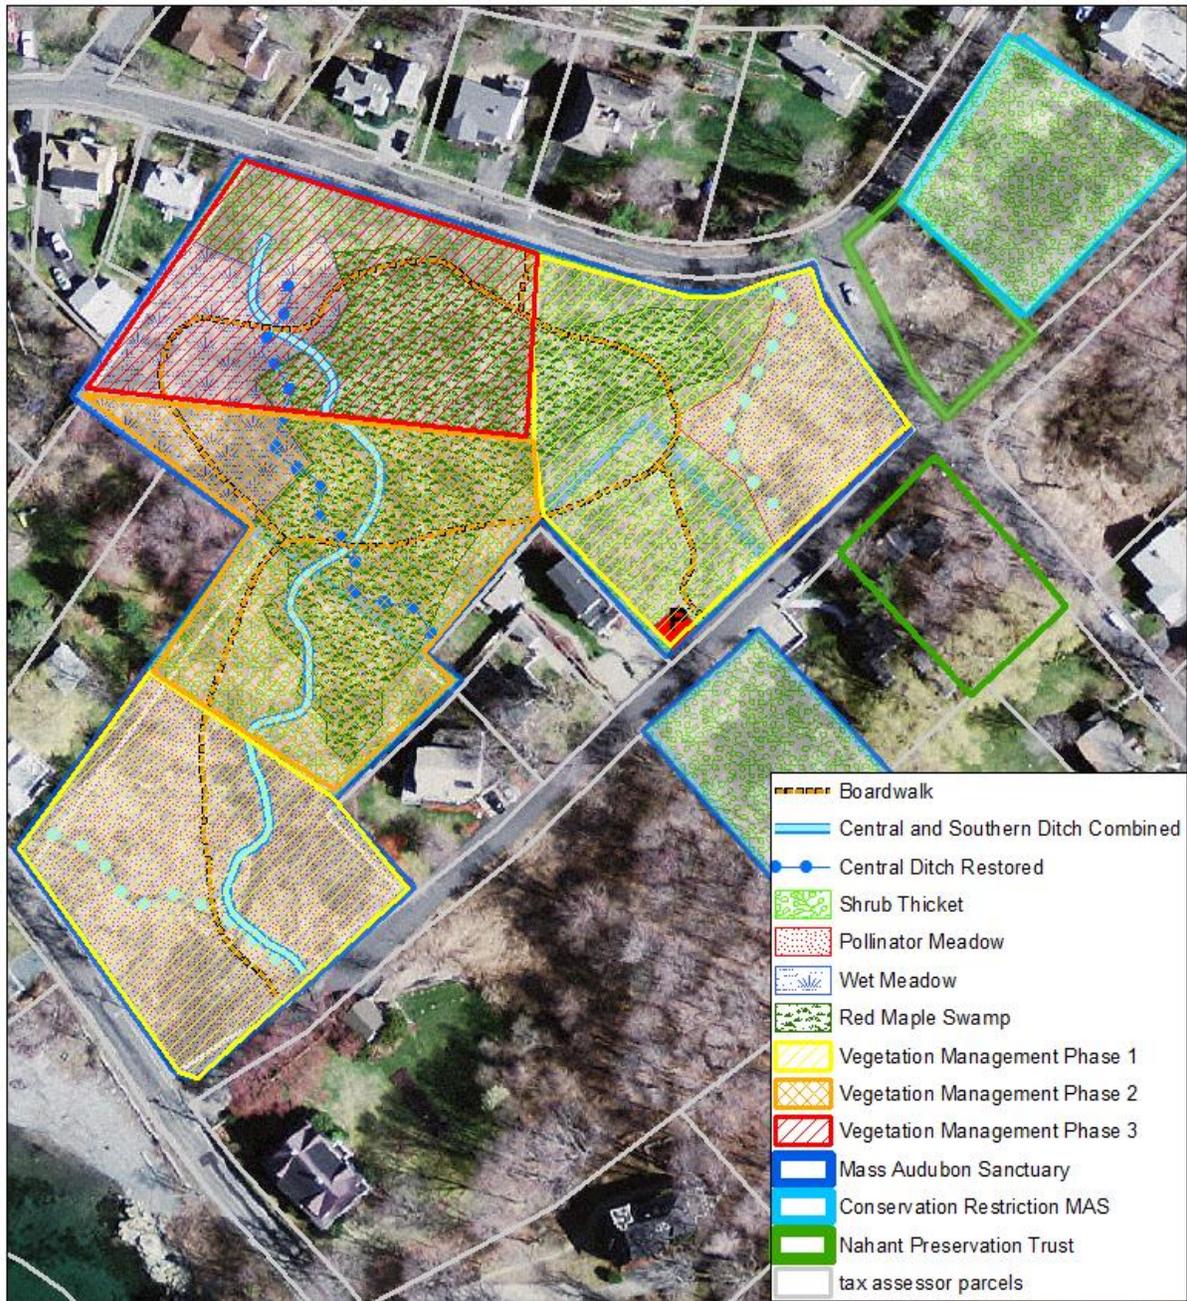
Moving west along Wharf Street, a more selective removal process will take place during phase three of vegetation management (Figure 10). As this stretch of the boundary features more native trees and fewer invasives, we will focus on removing the invasives so natives in the understory have the opportunity to flourish. Species such as Norway maples will be removed, releasing several smaller individuals of American basswood, black cherry and horse-chestnut. This more selective removal approach will favor the growth of native species as well as maintain the wooded edge of the property. Removing these mature invasive species will also prevent these species from recolonizing restored areas of the sanctuary.

Figure 10: Vegetation Management will be conducted in phases and opportunistically with installation of boardwalk and ditch restoration so that no one entire habitat type is treated at the same time.

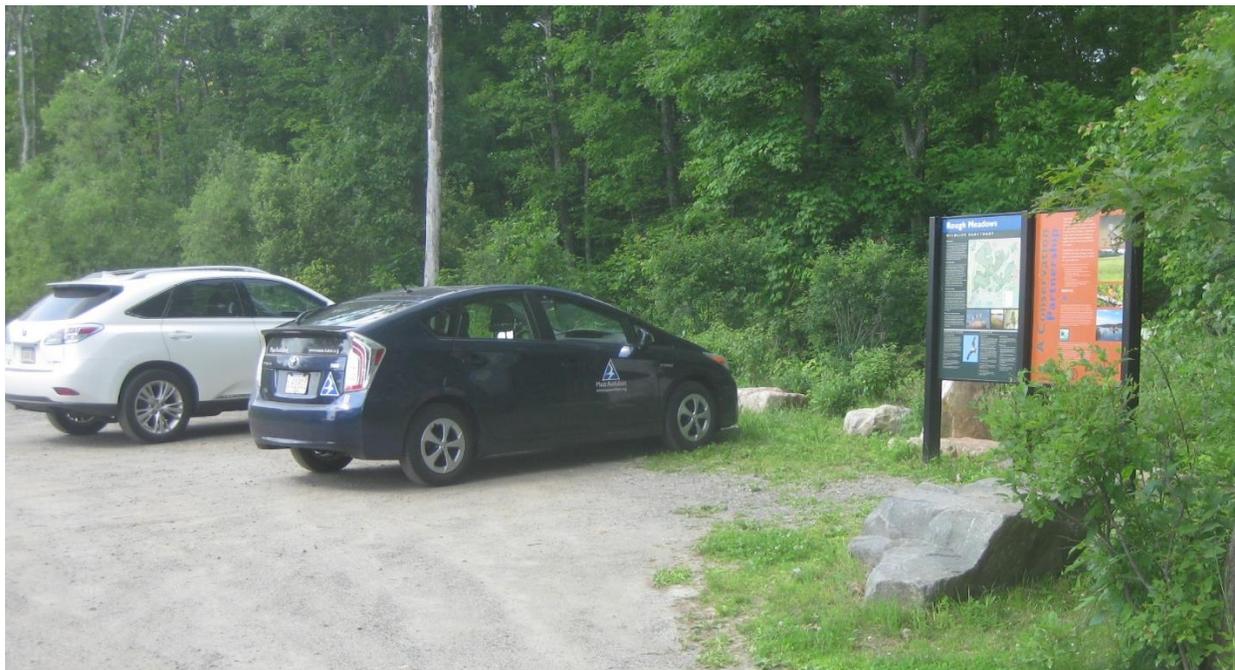
Figure 11. An example of a gravel lot with granite stone parking bumpers, Rough Meadows Wildlife Sanctuary, Rowley.

We will work with colleagues to design and install standard Mass Audubon sanctuary signage that would welcome visitors, indicate the access points and trails into the Thicket, and clearly state that parking is not permitted for beach access. A welcome kiosk will provide background information about the Thicket, information about the trail system and safety risks such as poison ivy and ticks. A similar lot at our Rough Meadows Wildlife Sanctuary in Rowley is shown in Figure 11 and typical signage is shown in Figure 12.

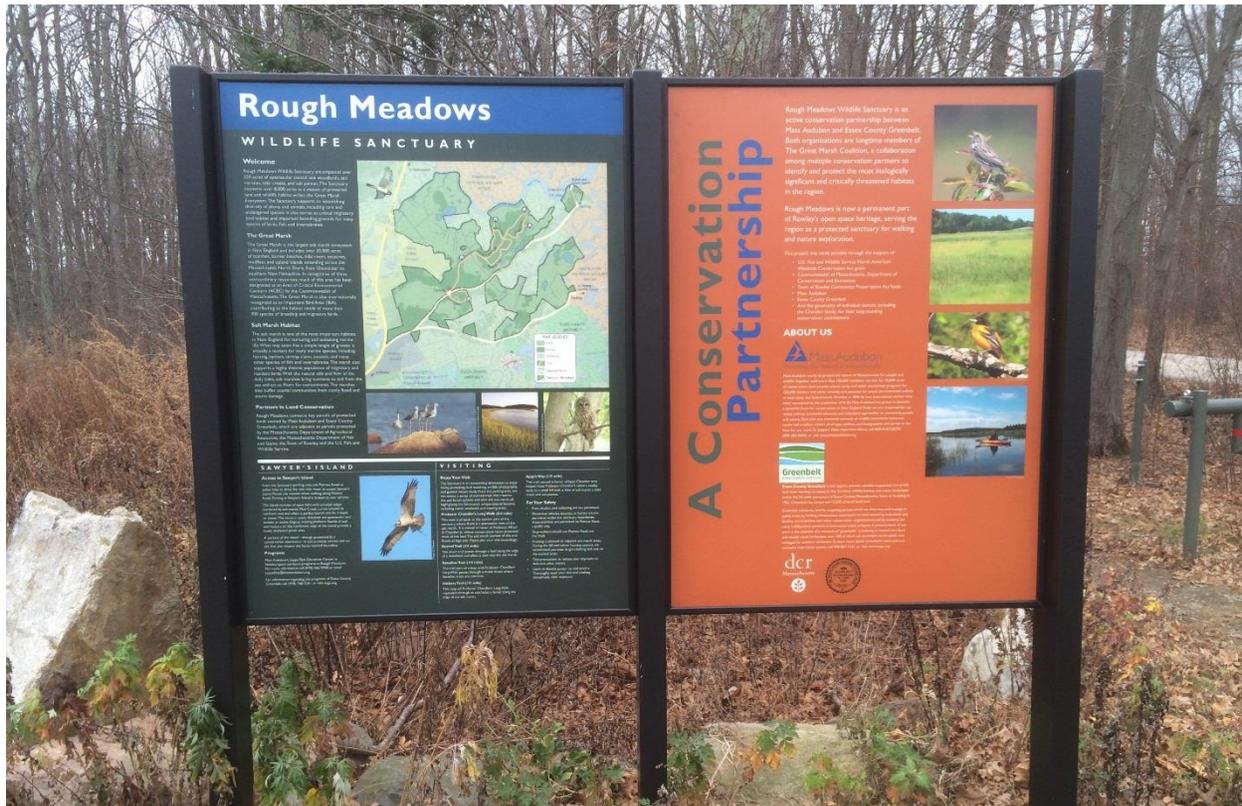
Figure 12. Example of informational signage at Rough Meadows Wildlife Sanctuary, Rowley.

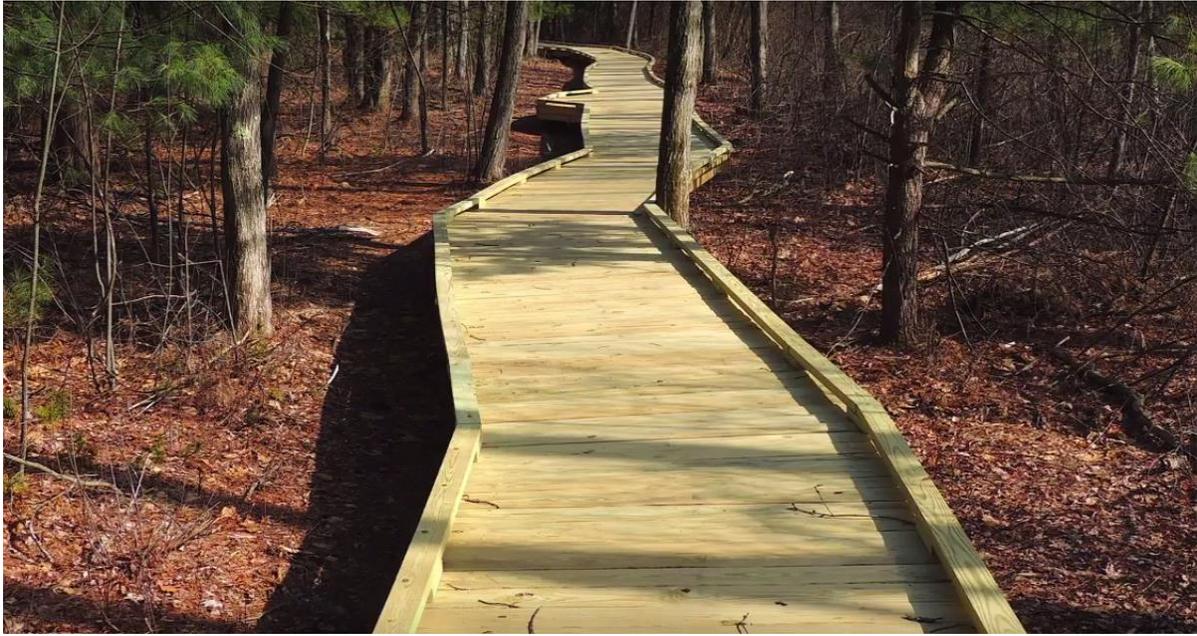
The boardwalk will use a modern design that we employed for the Red Maple Trail in partnership with U.S. Fish & Wildlife Service at the Great Meadows National Wildlife Refuge in Sudbury (Figure 13). This method makes use of metal posts augured into the soil, holding the boardwalk structure above the moist ground and involving minimal disturbance of soil. We will trim vegetation modestly, to ensure a clear walking path.

Figure 13. Raised boardwalk at Great Meadows NWR, Sudbury.
