Nahant Thicket Wildlife Sanctuary Ecological Restoration and Maintenance Plan

Mass Audubon's Ecological Extension Service

September 2017

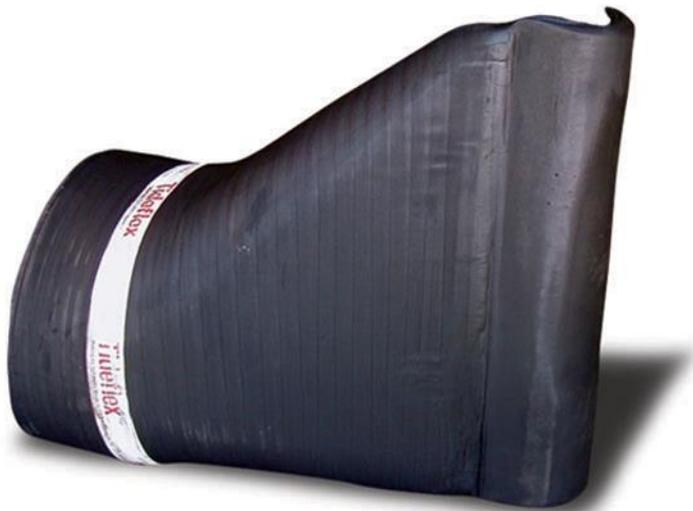
According to a former town engineer and a long-time neighbor, the stormwater pipes are old and have not been regularly maintained in recent years, with the last power flushing of the pipes 10-15 years ago. During the site visit, trash and debris were observed covering all pipe inlets as well as within the upstream manhole, and sand and gravel were blocking the outlet of the pipe on the beach. With regular, possibly seasonal, maintenance that includes the removal of blockages from all inlets and a power flushing of the pipes, the functionality of the current stormwater system could be improved. In addition, a check valve such as the Tideflex Check Valve (Figure 14) could be added to the outfall pipe on the beach. This device would prevent accumulated sand and gravel from blocking drainage.

Figure 14: The TF-1 Tideflex Check Valve, an alternative to the existing flap gate.
