***Phragmites*: Controlling the All-Too-Common Common Reed**

Massachusetts Wetlands Restoration Technical Notes

Technical Note Number 1 April 1995

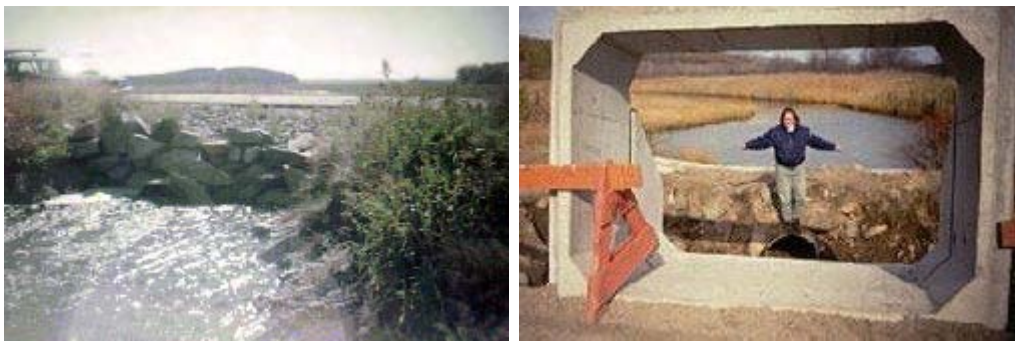
This restrictive culvert at Argilla Rd. in Ipswich has now been replaced by a much bigger box culvert, allowing the natural flow of the tide.

7. Increase tidal flow and salinity (for controlling common reed in former salt marshes). Successful technique. Requires increasing size of culverts, installing self-regulating tide gates, or otherwise removing the restriction to permit more tidal water exchange. May be enhanced through open marshwater management which involves increasing salt water flooding through selective ditching and ponding. This has resulted in a significant die-back of common reed after four years. Installation of self-regulating tide gates can both increase tidal flooding with salt water and protect low-lying developed areas from storm floods, thereby providing environmental, safety, and economic benefits.

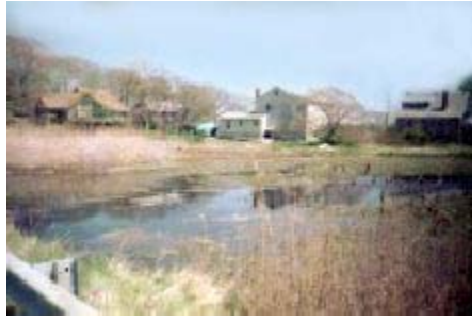
Stormdrain discharge has led to increased elevation, favoring Phragmites on this site in Rockport, MA
