Stream Continuity in the Taunton River Watershed

Protecting Aquatic Passage from headwaters to Mount Hope Bay

Taunton River Watershed Stream Continuity Project

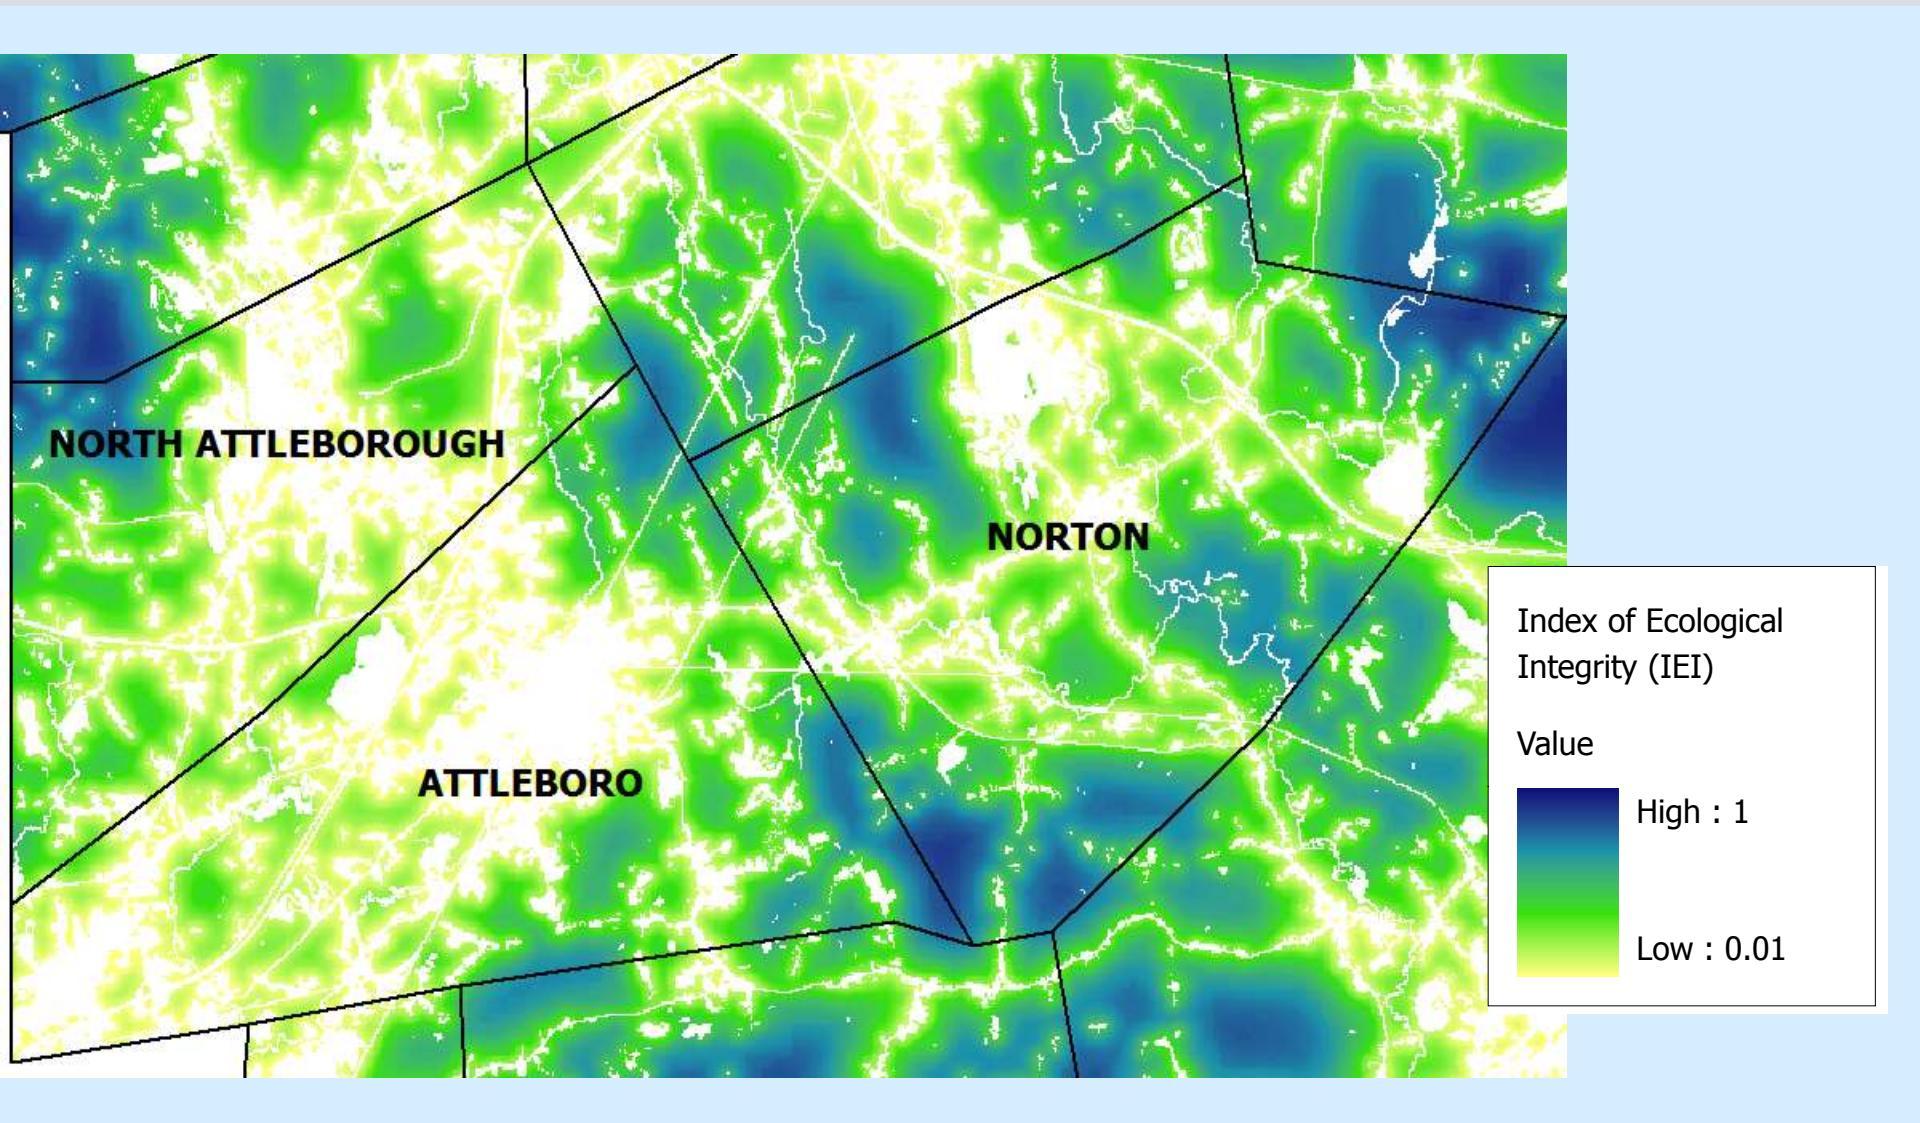
Ecological Value in 1971

CAPS was developed by researchers at the University of Massachusetts, Amherst, Department of Natural Resources Conservation and Mass Audubon. The program evaluates developed and undeveloped elements of the Massachusetts landscape and assigns a score, or "Index of Ecological Integrity (IEI)."

The highest rankings go to large intact ecological systems - forests, wetlands, rivers and streams – that are not fragmented by roads or other human development, or are connected to each other by a natural corridor, and are not impacted by nutrient loading to aquatic systems or other adverse impacts.

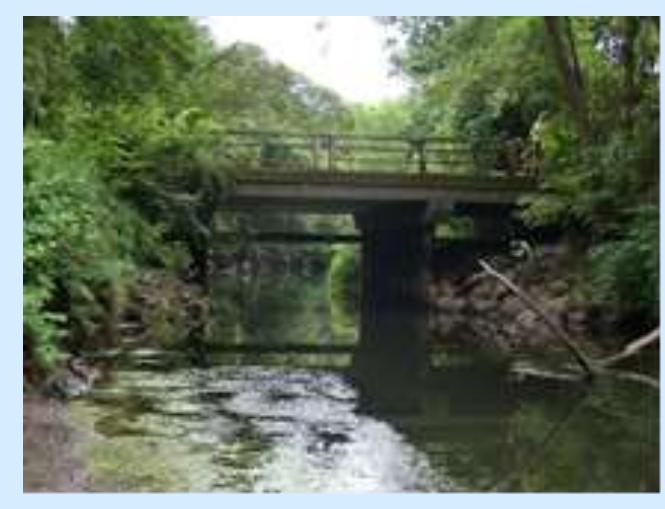
Spring Street, East Bridgewater

Many crossings that were evaluated preserve the natural condition of the stream or river, or cause minimal alteration.

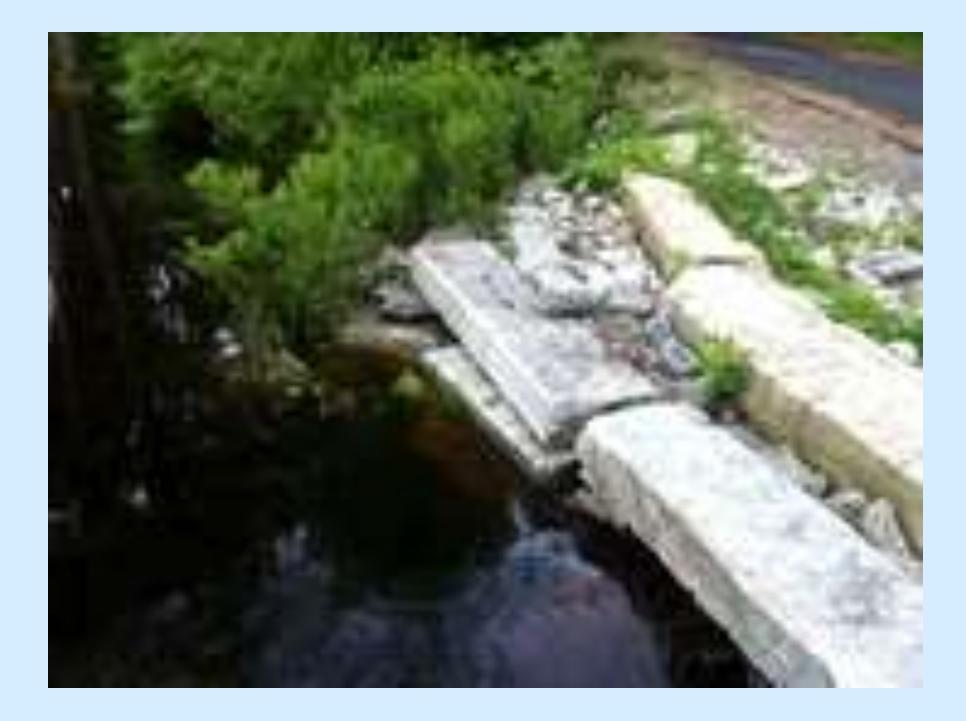
Blocked or collapsed culverts prevent wildlife from passing though and lead to severe flooding following intense rainstorms preventing wildlife from passing through.

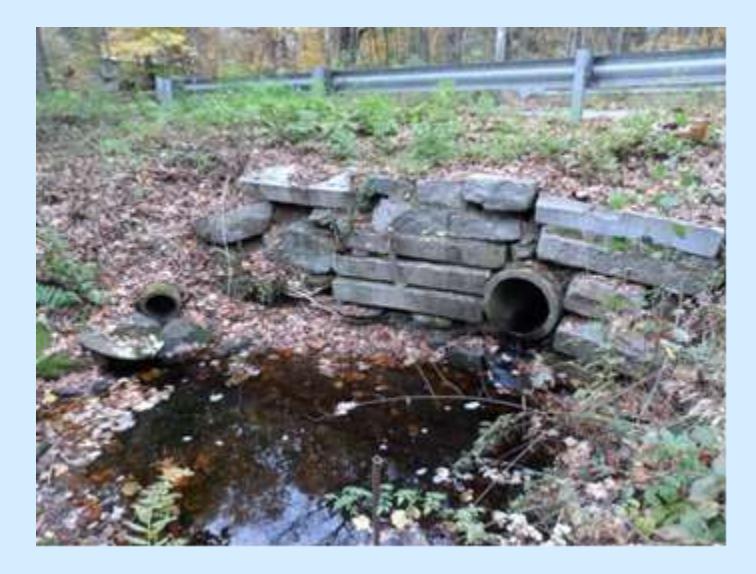
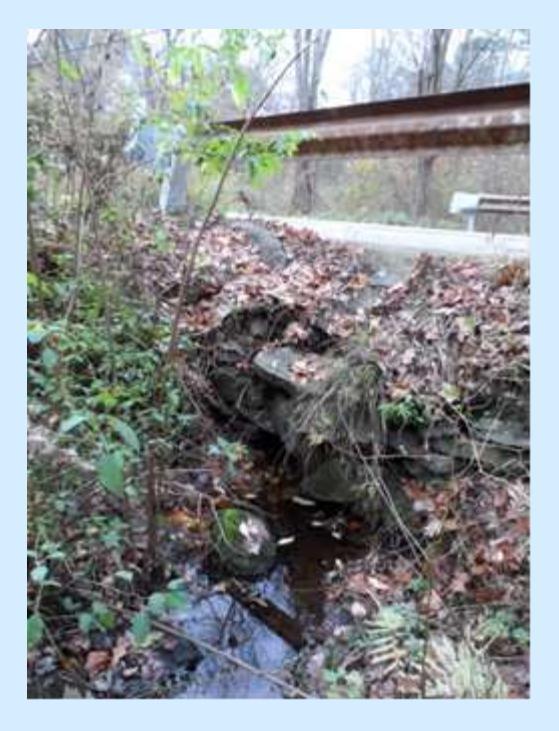
Culverts that are elevated above normal stream heights prevent wildlife from moving upstream. In addition, they cause water impoundment.

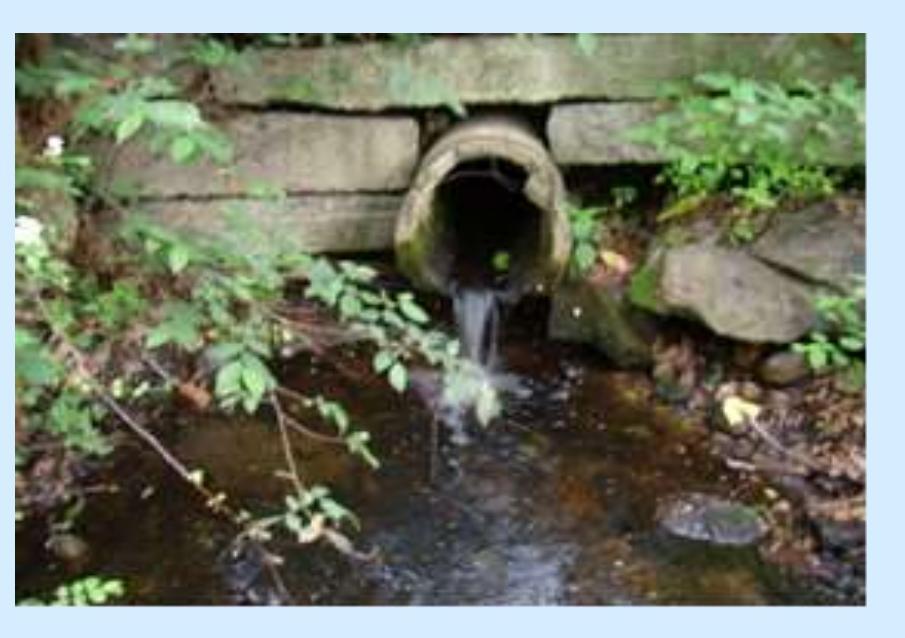
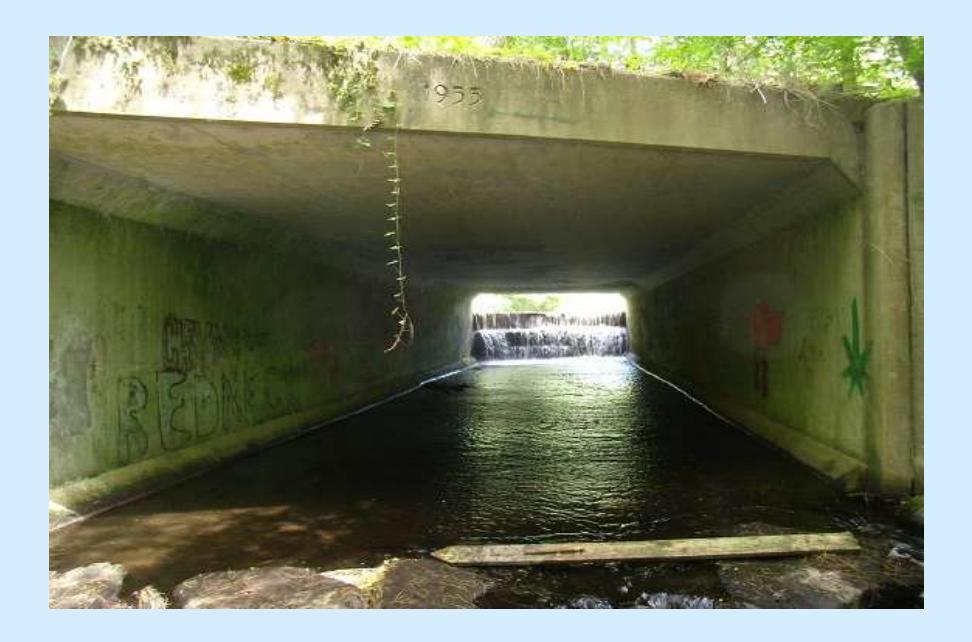
Drops in elevation at the inlet or outlet of a culvert create barriers for passage of small fish and other organisms, such as turtles.

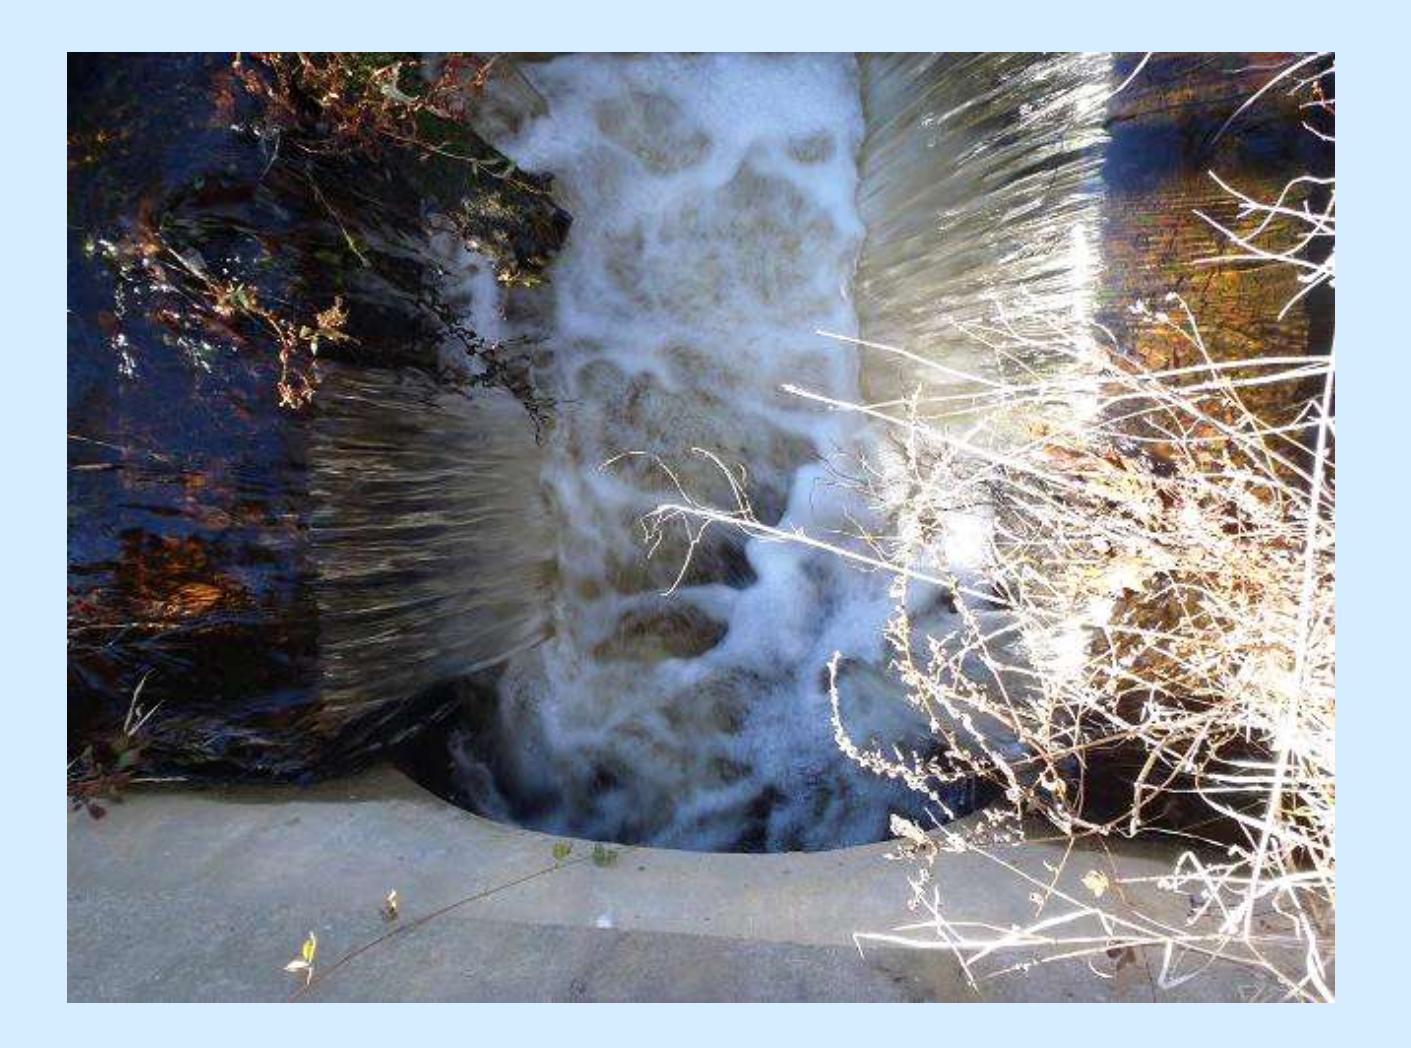
Inlet at North Walker Street, Taunton

7. Fall Brook, North Walker Street, Taunton: 0.4938. Inlet drop of 36"

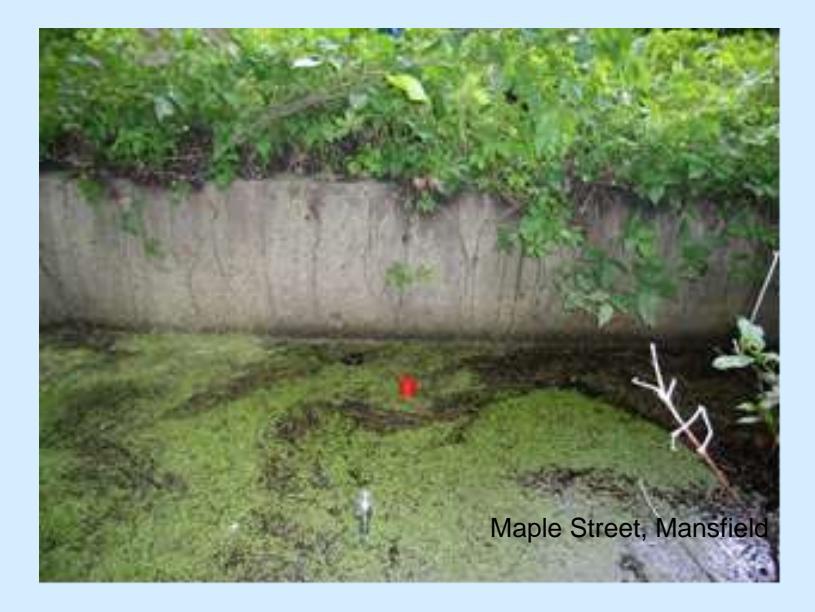
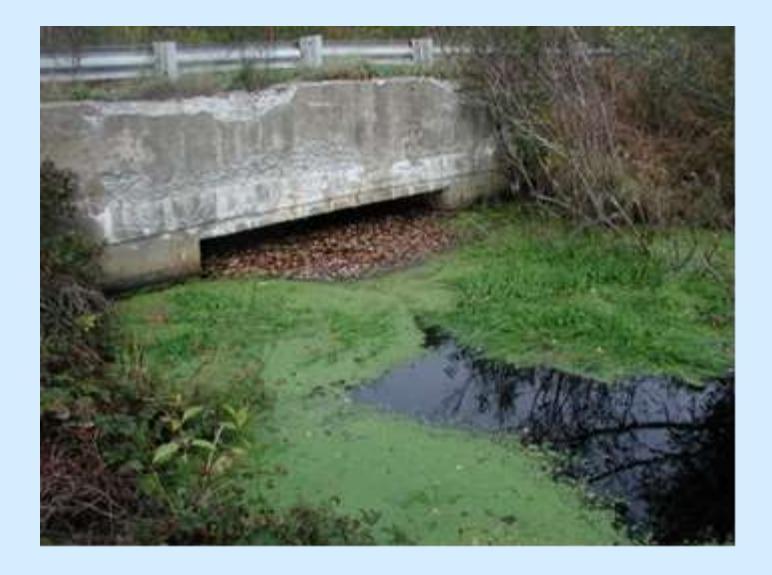
Water impoundment causes algae bloom, lowered dissolved oxygen levels, and other pollution problems. These areas are also prime breeding ground for mosquitoes.
