Eastern Point, Gloucester Average Salinity Pre and post restoration

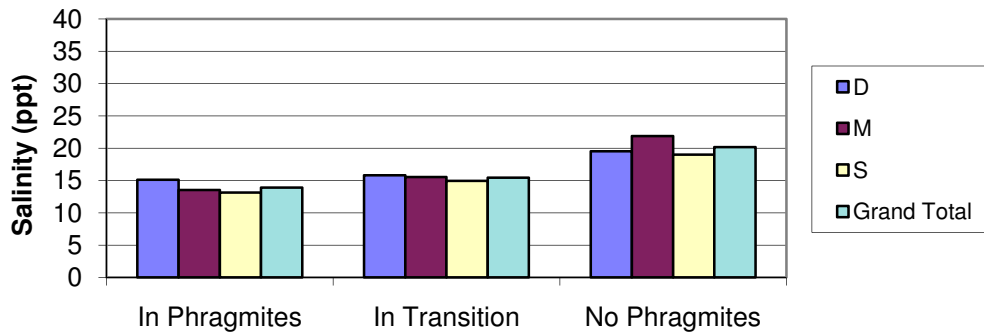
Salinity vs. Presence of Phragmites Eastern Point, Gloucester 2000-2009

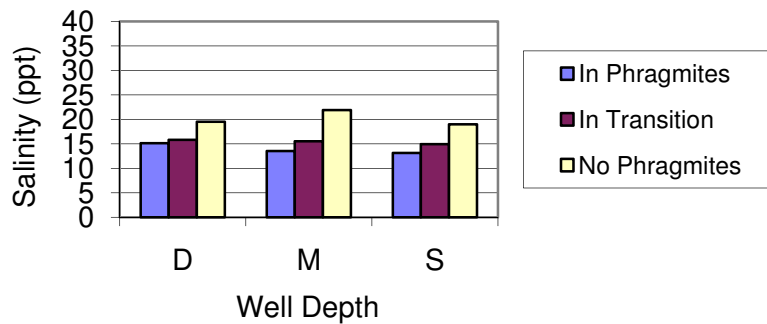
Average Salinity vs. Well Depth Eastern Point, Gloucester 2000-2009

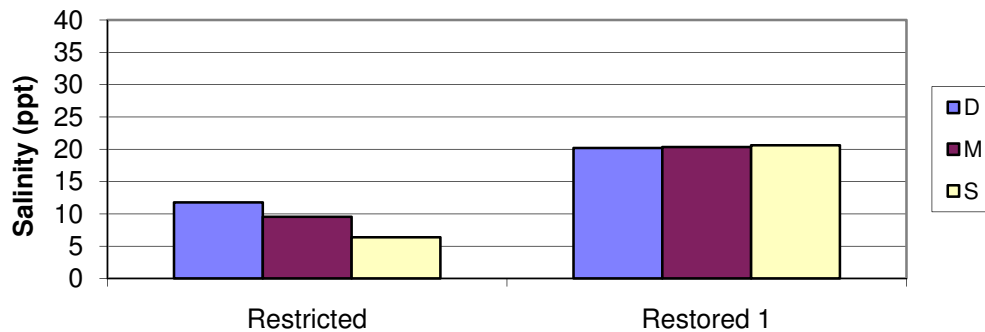
Average Salinity Change vs. Depth for Transect 1, Eastern Point, Gloucester

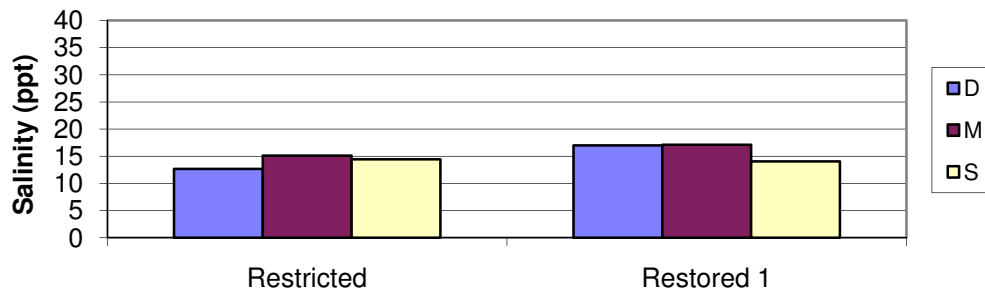
Average Salinity vs. Pre and post restoration Transect 3, Eastern Point, Gloucester 2000-2001 vs. 2004-2008

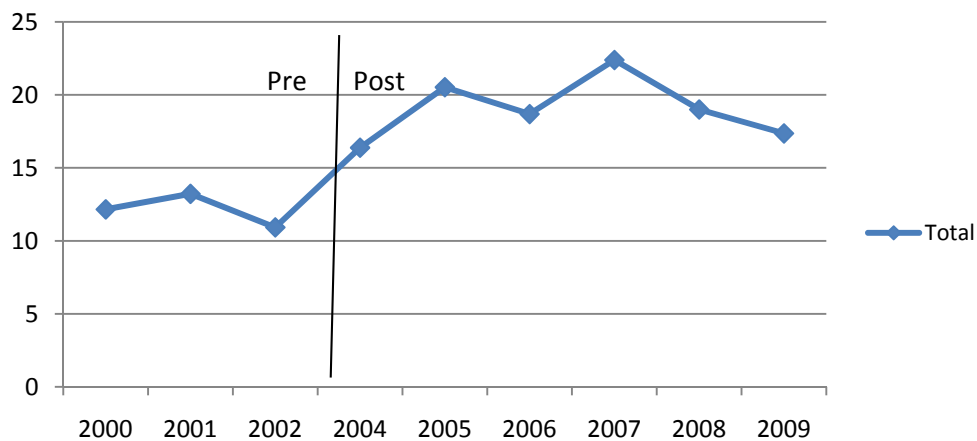
Eastern Point Average Salinity by Year
