Conomo Point, Essex, Average # Mummichogs vs. Location and pre or post restoration (1998-2000=pre, 2001-2008=post)

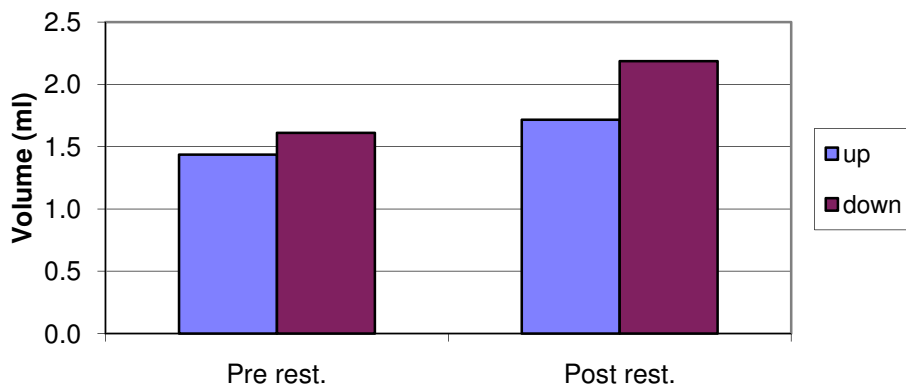
Conomo Point, Essex, MA Average Volume Mummichogs vs. treatment vs. location

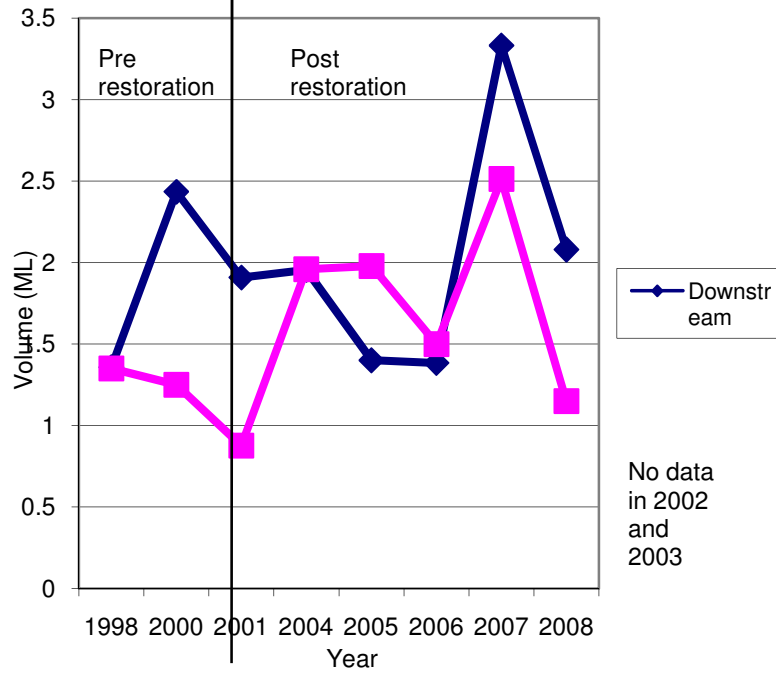
Average Mummichog Volume by Year Conomo Point Essex

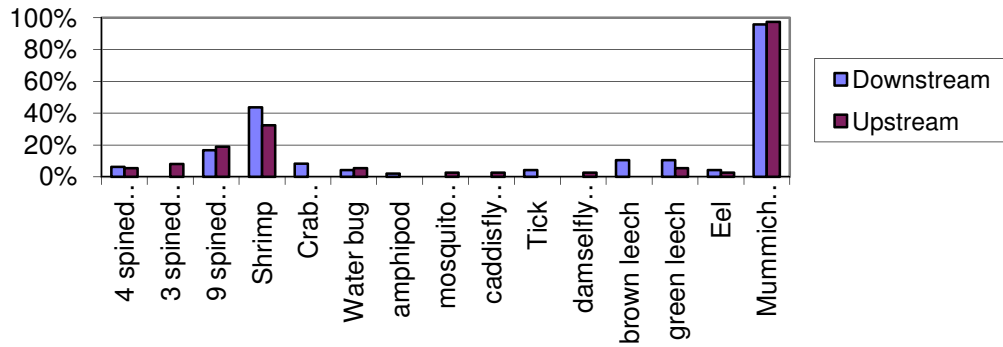
Conomo Point, Essex Percent Frequencies of Different Species 1998-2008

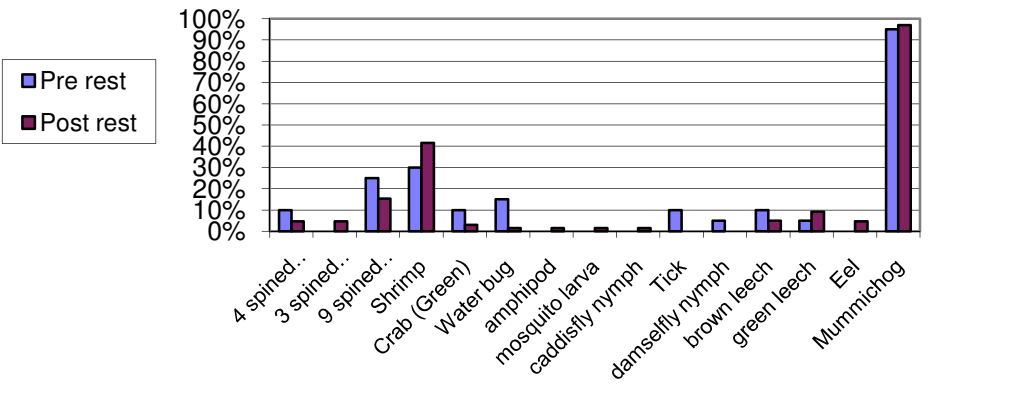
Conomo Point Essex Percent Frequency of different species pre and post restoration 1998-2008

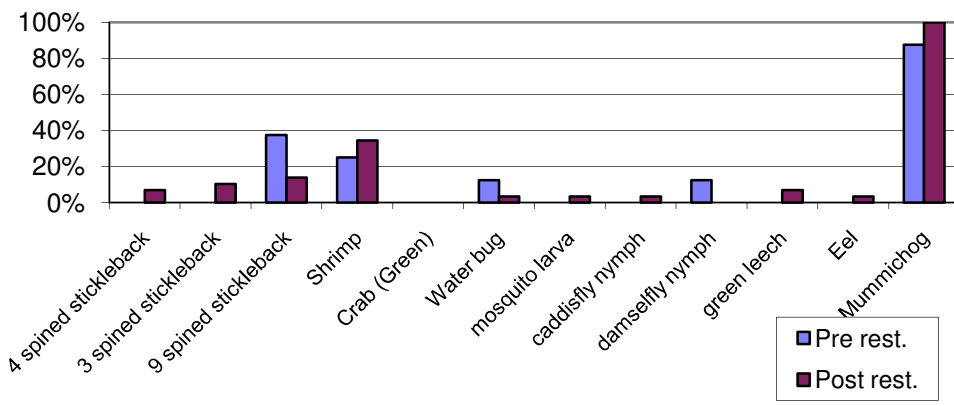
Conomo Point, Essex Percent Frequency of Different Species Upstream pre and post restoration (1998-20078)

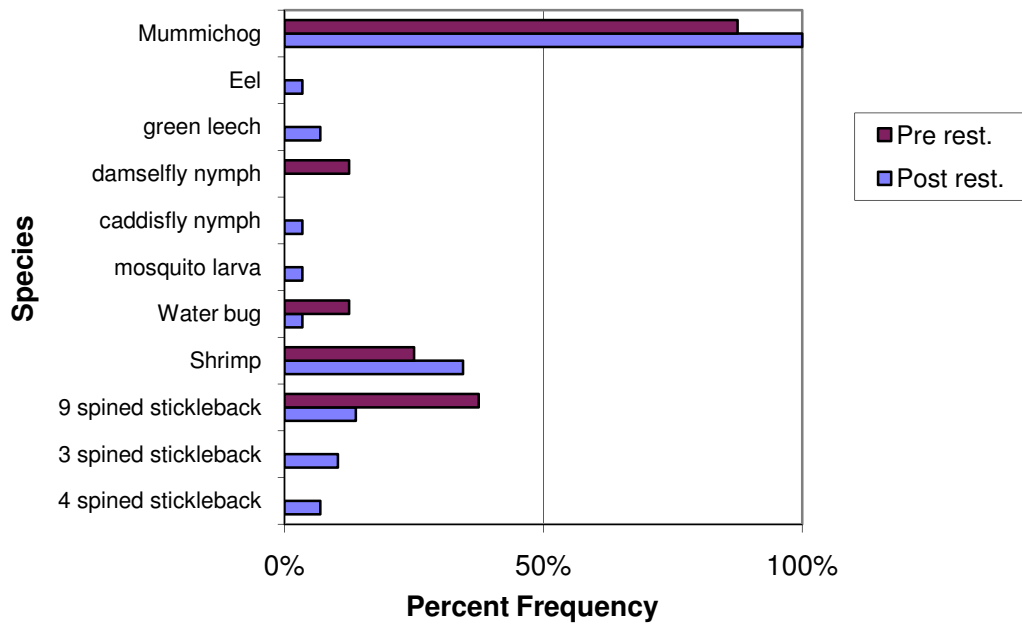
Percent Frequency of species upstream at Conomo Point Road, Essex Pre and post restoration.

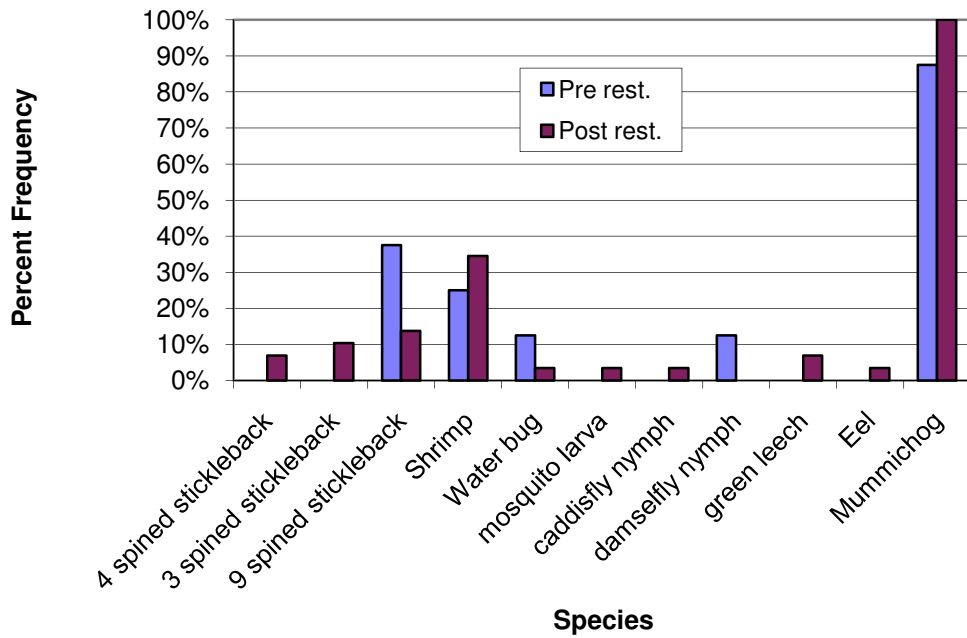
Species upstream pre and post restoration.
