Eastern Point, Gloucester Average Salinity Pre and post restoration

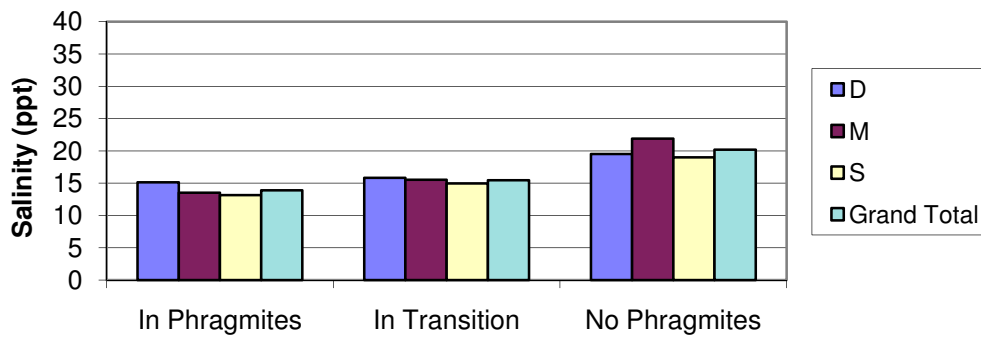
Salinity vs. Presence of Phragmites Eastern Point, Gloucester 2000-2008

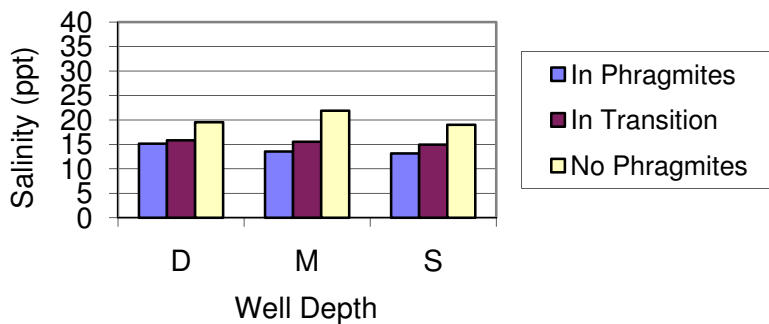
Average Salinity vs. Well Depth Eastern Point, Gloucester 2000-2008

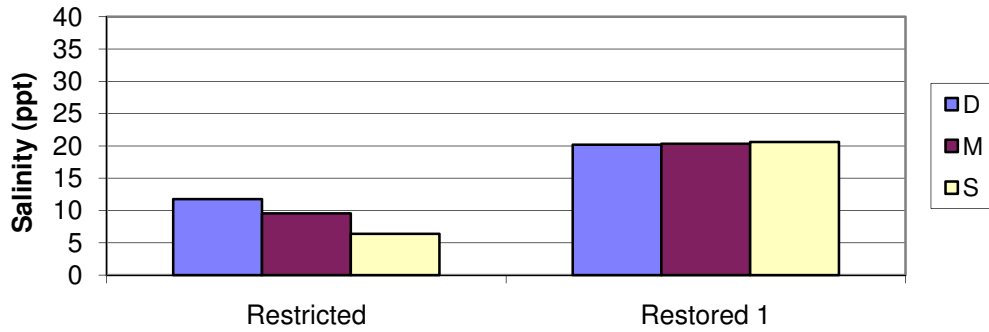
Average Salinity Change vs. Depth for Transect 1, Eastern Point, Gloucester

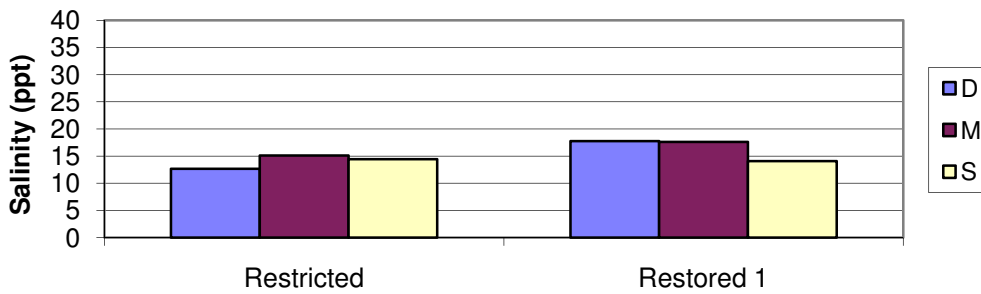
Average Salinity vs. Pre and post restoration Transect 3, Eastern Point, Gloucester 2000-2001 vs. 2004-2008

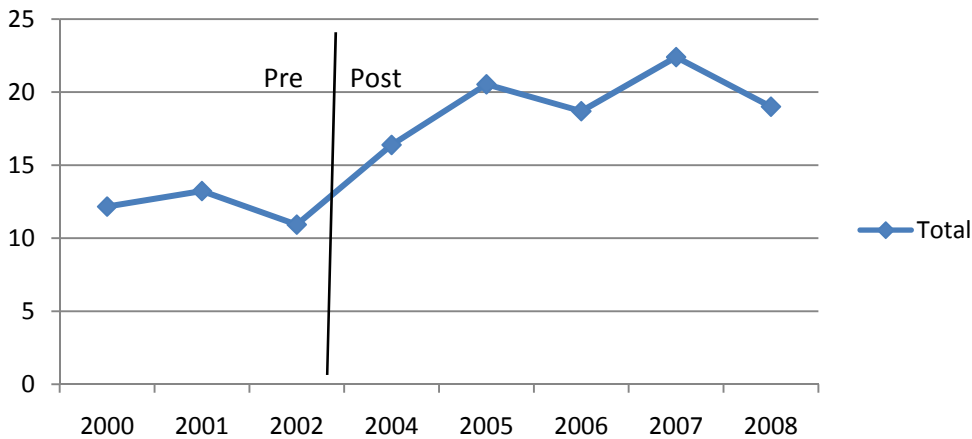
Eastern Point Average Salinity by Year
