**Mill Pond, Gloucester 1998-2001,  
2004-2010 (Tidegates opened)  
2011-2018 (Tidegates Widened)  
Average Salinity vs. Site Treatment Status**

**Mill Pond, Gloucester Restricted (1998-  
2001), vs Tidegates open (2004-  
2018) Average Salinity vs. Presence of  
Phragmites**

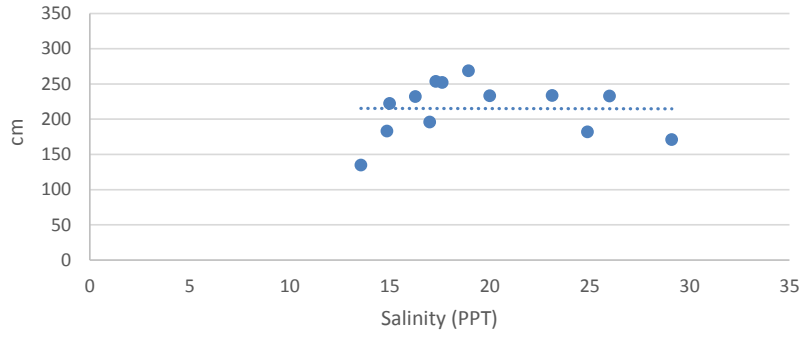
Av Phragmites Hts Vs Salinity T.5 Mill River, Gloucester

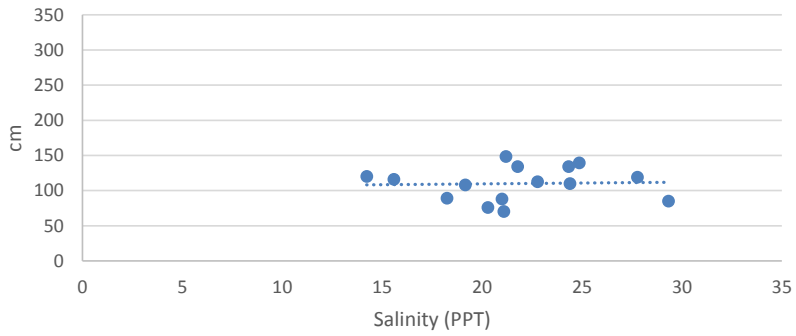
Av Phragmites Hts Vs Salinity T1 Mill River, Gloucester

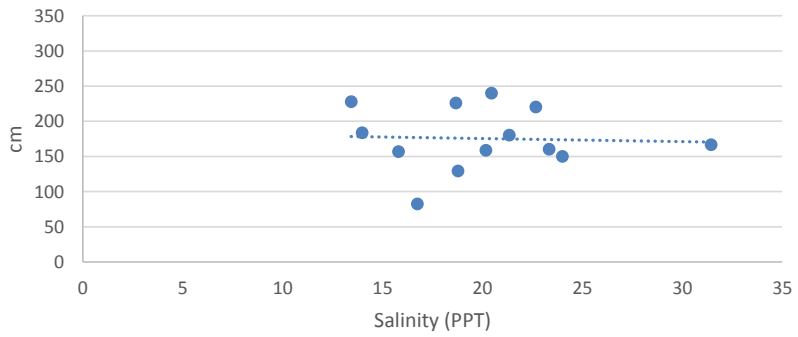
Av Phragmites Hts Vs Salinity T2 Mill River, Gloucester
