Conomo Point, Essex, Average # Mummichogs vs. Location and pre or post restoration (1998-2000=pre, 2001-2008, 2013=post)

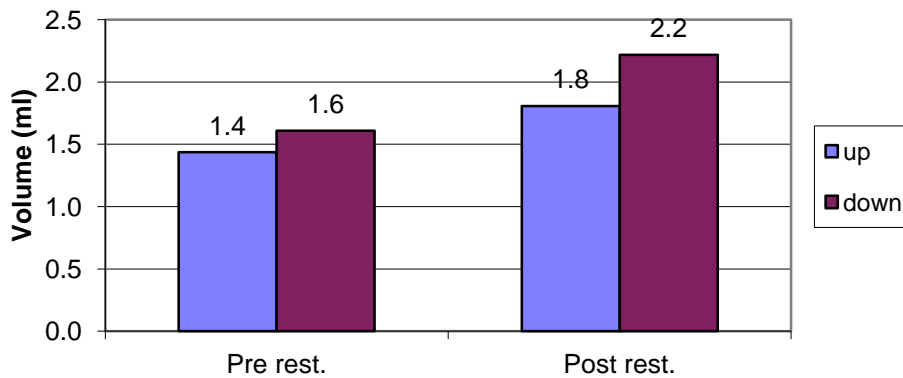
Conomo Point, Essex, MA Average Volume Mummichogs vs. treatment vs. location

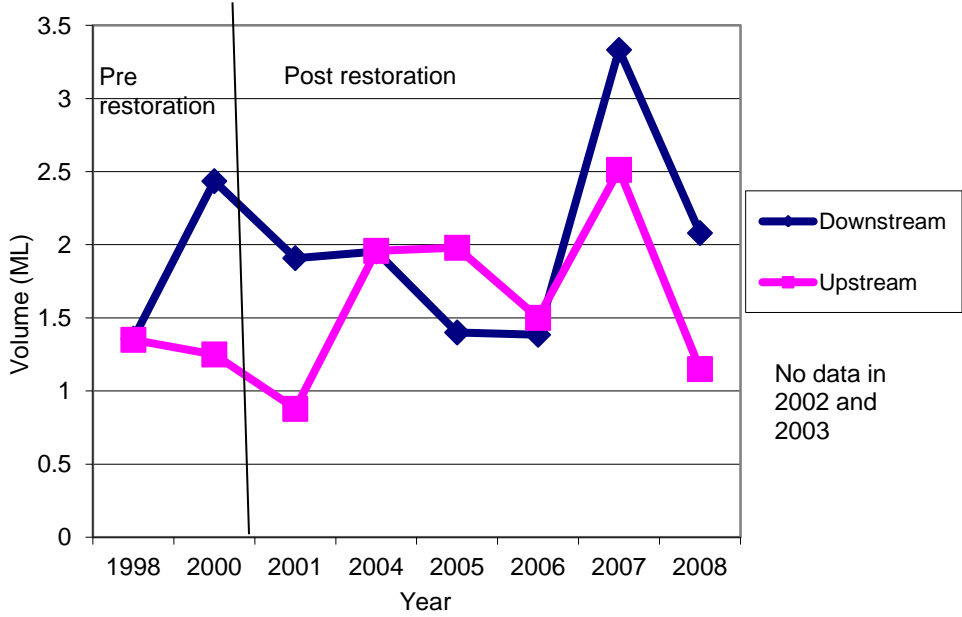
Average Fall Mummichog Volume by Year Conomo Point Essex

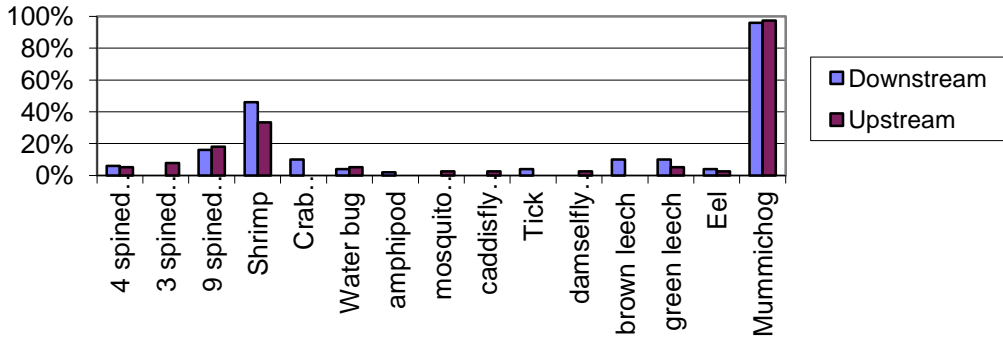
Conomo Point, Essex Percent Frequencies of Different Species 1998-2008, 2013

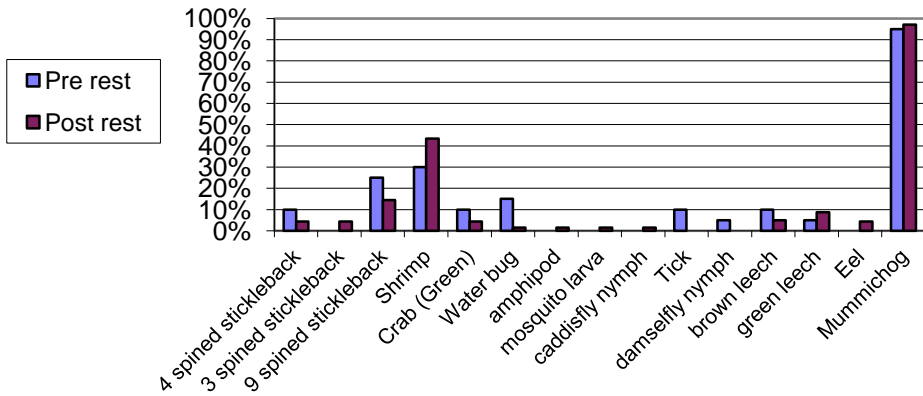
Conomo Point Essex Percent Frequency of different species pre and post restoration 1998-2008, 2013

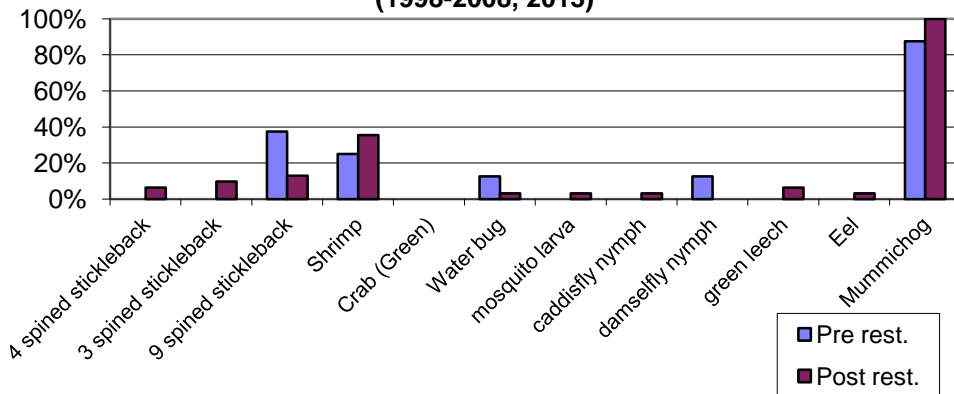
Conomo Point, Essex Percent Frequency of Different Species Upstream pre and post restoration (1998-2008, 2013)

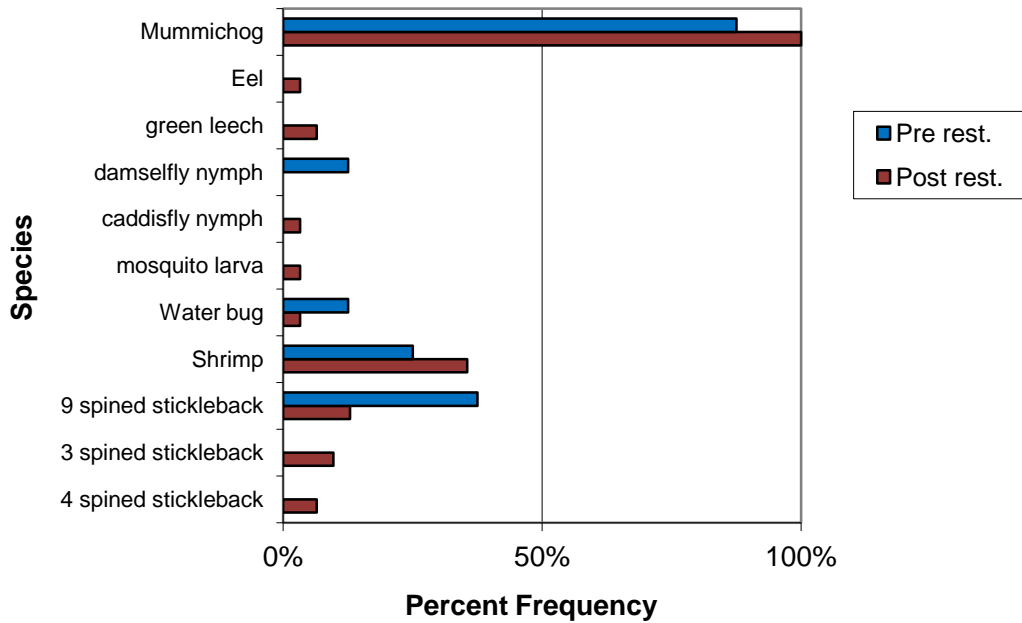
Percent Frequency of species upstream at Conomo Point Road, Essex Pre and post restoration.

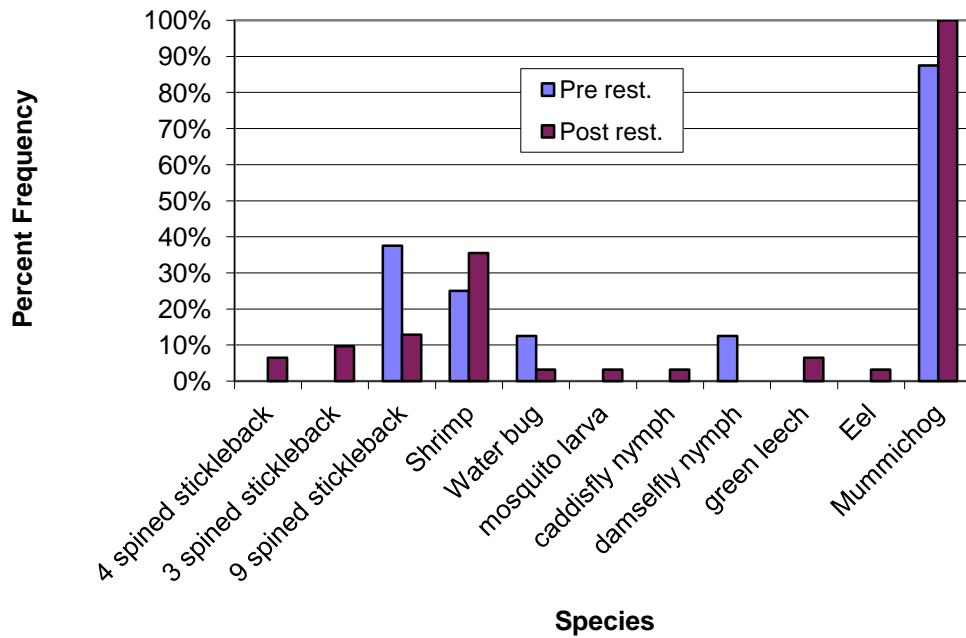
Species upstream pre and post restoration.
